ALASKA NATIVE  
TRIBAL HEALTH  
CONSORTIUM

RE: Sanitary Survey of the Saint Paul Island Community Water System

## Sanitary Survey Photo Log

August 7th, 2024

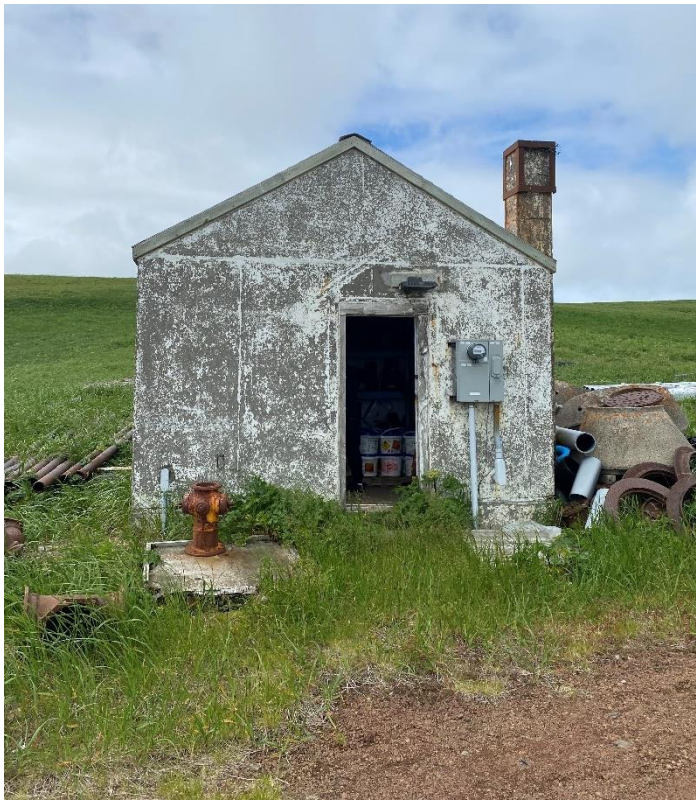
- 13 Is the well site properly drained? (i.e. sloping away from the casing for 10 feet in all direction. Note condition of the surface around the casing using a description and photo documentation that shows the well both close up and from a distance.) ☒ Yes  
☐ No  
Notes: The well is located inside of a well house (see photos 1 & 2). The well house is on a hill.

Photo 1: Well house building in good condition.

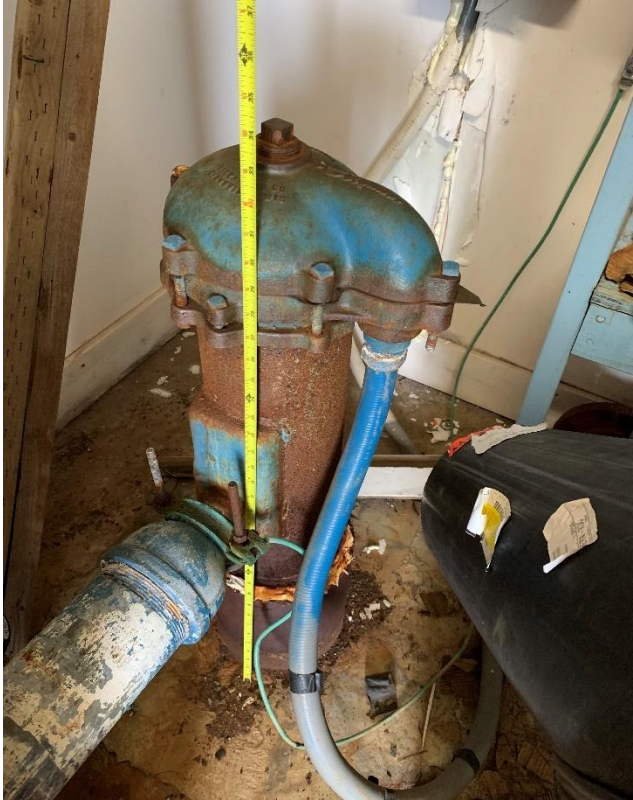
- 7 Is the well casing intact (i.e. unsealed hole or break, corrosion, visible damage, etc.)? Describe the condition in notes. ☒ Yes  
☐ No  
Notes: There is some corrosion around the well cap.

Photo 2: South well casing 29 inches above floor.

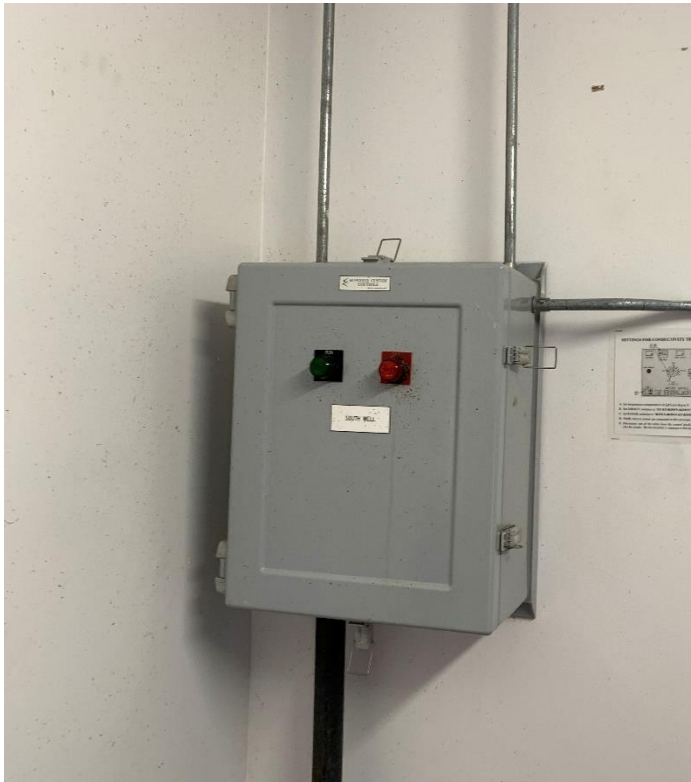
Photo 3: South well control panel.

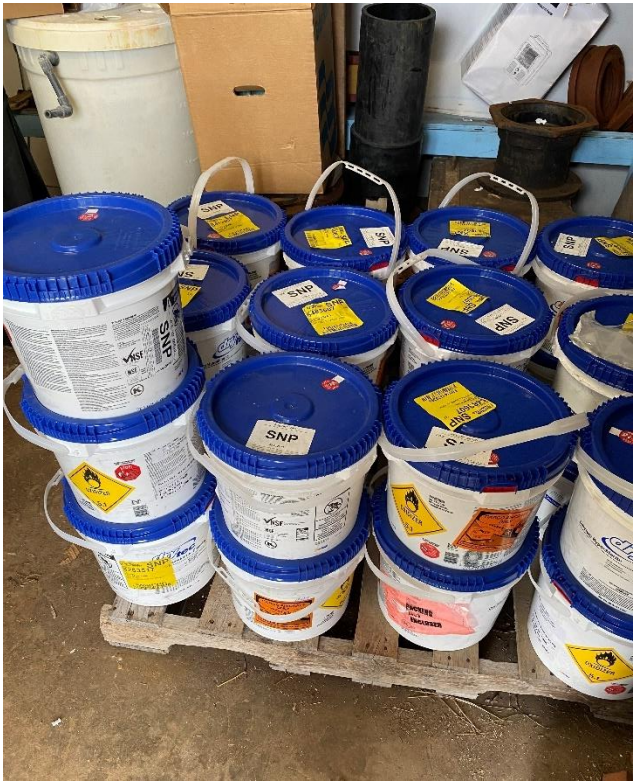
Photo 4: Extra supply of calcium hypochlorite disinfectant chemical.

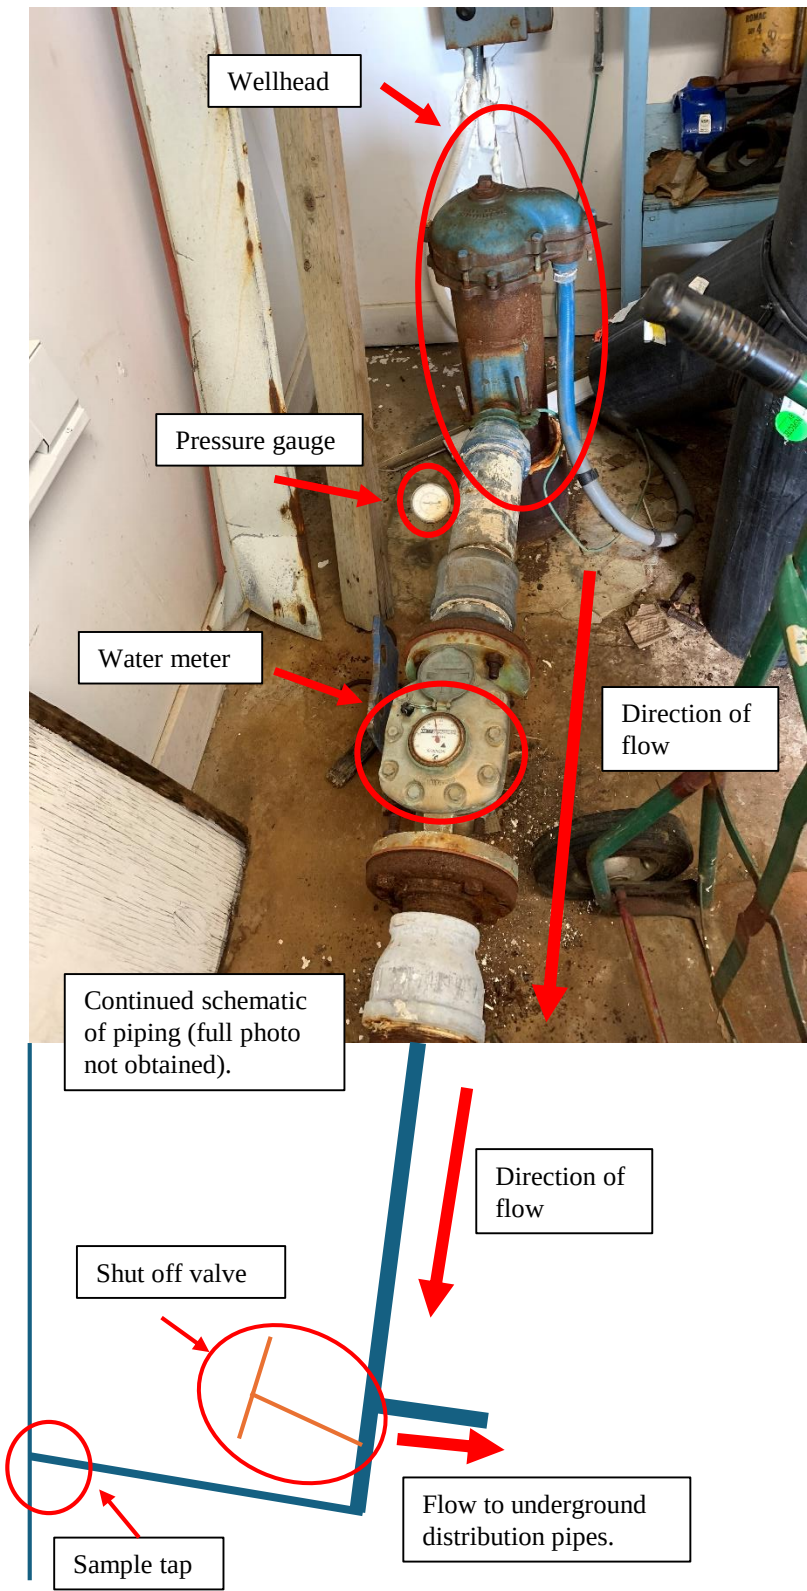
Photo 5: Interior components of south well house and drawn schematic to show the rest of the components that were not captured in photo.

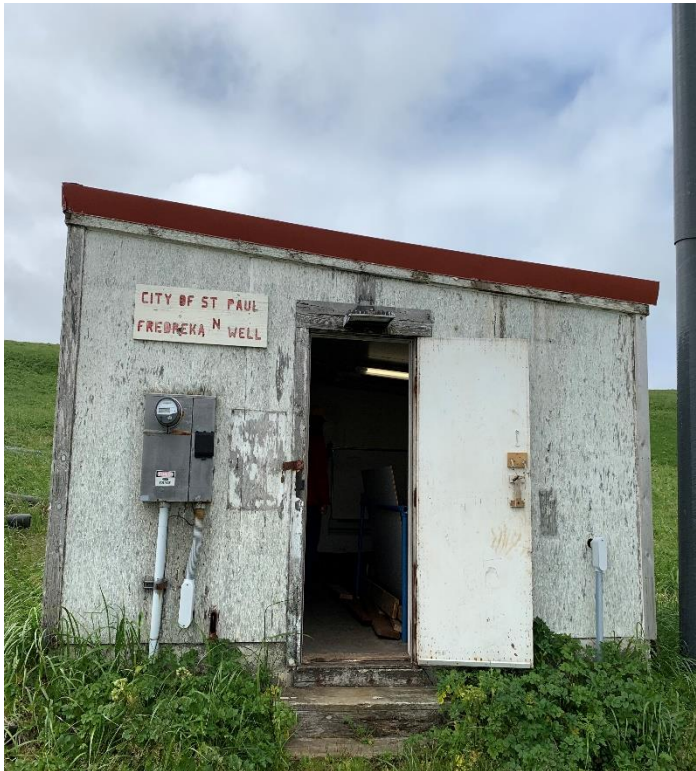
Photo 8: North well house building in good condition.

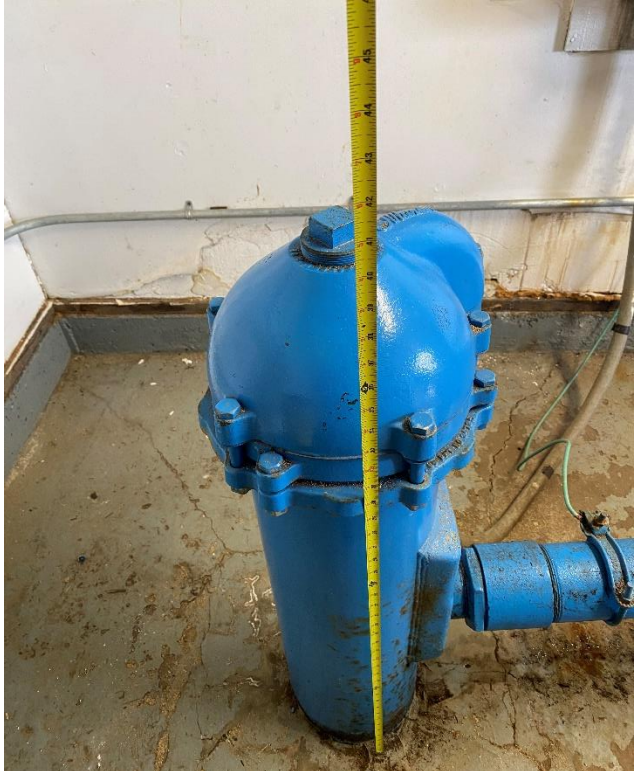
Photo 9: North well casing 31 inches above floor.

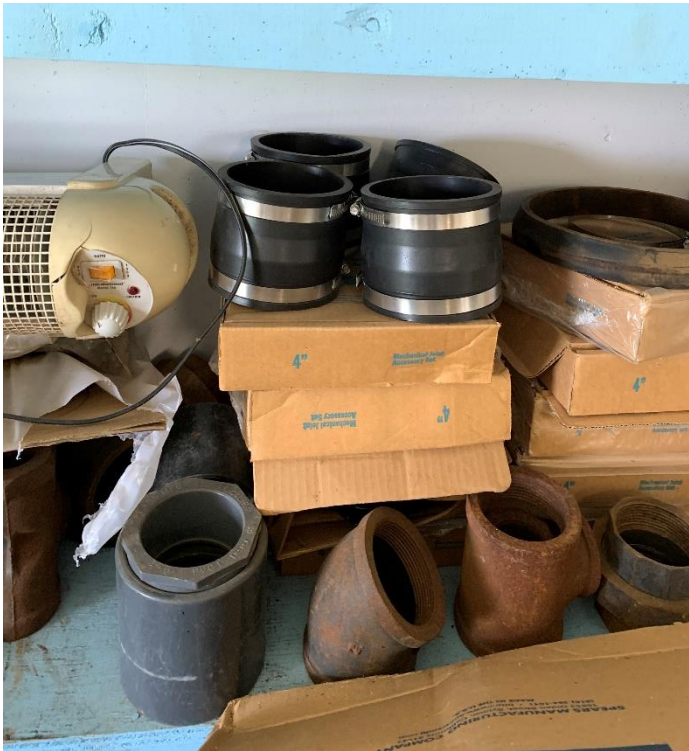
Photo 10: Supply of spare parts located in north well house.

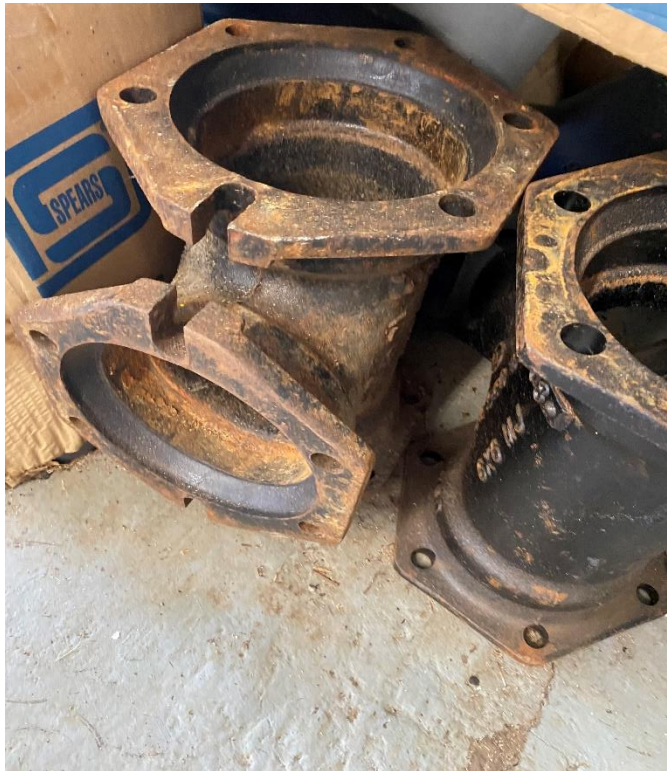
Photo 12: Supply of spare parts located in north well house.

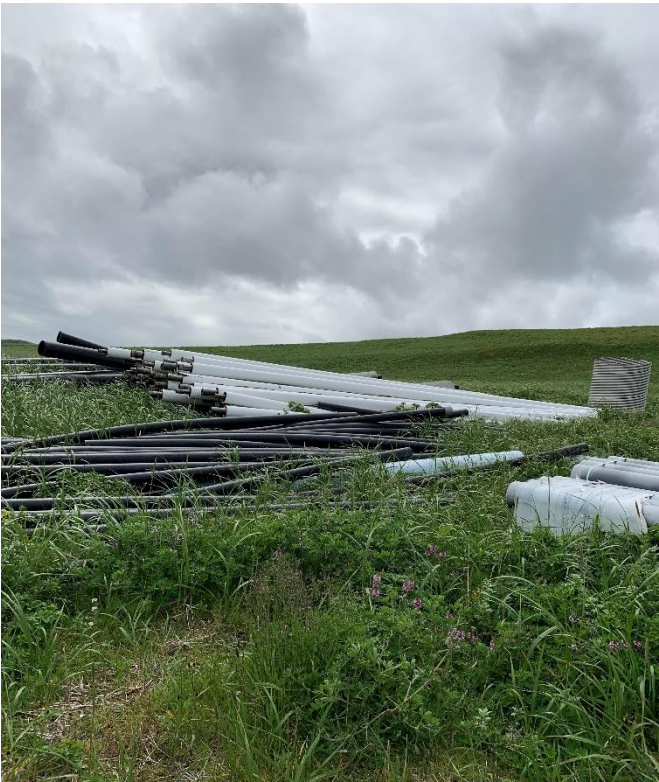
Photo 13: Spare distribution pipes outside of north well house.

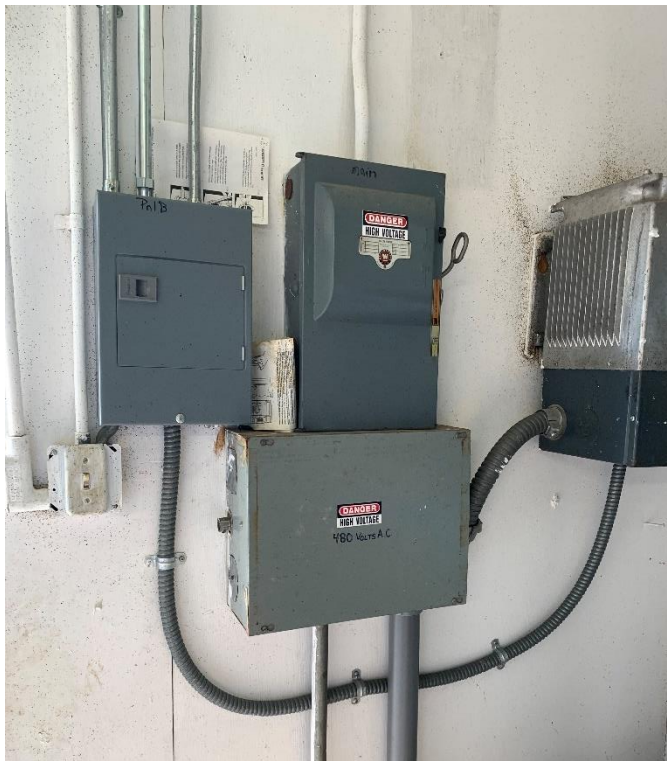
Photo 14: Electrical control panels located in north well house.

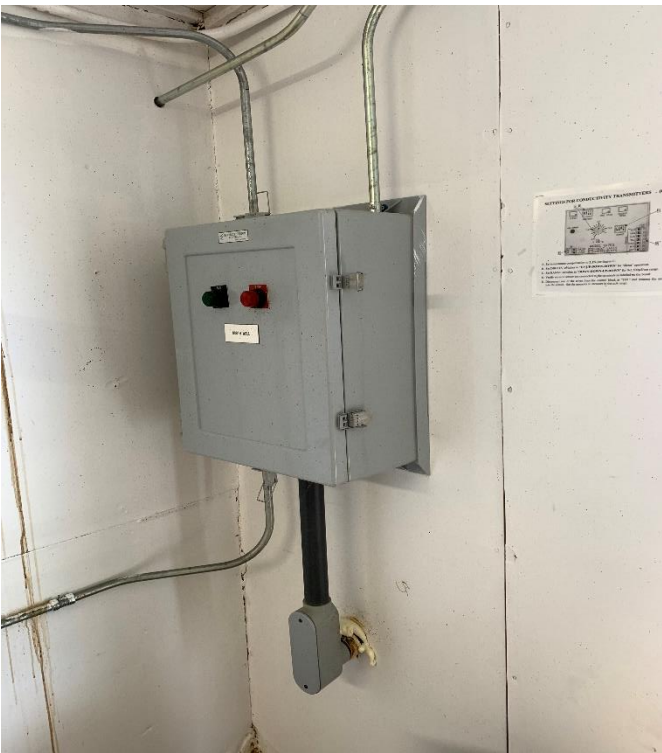
Photo 15: North well electrical control panel.

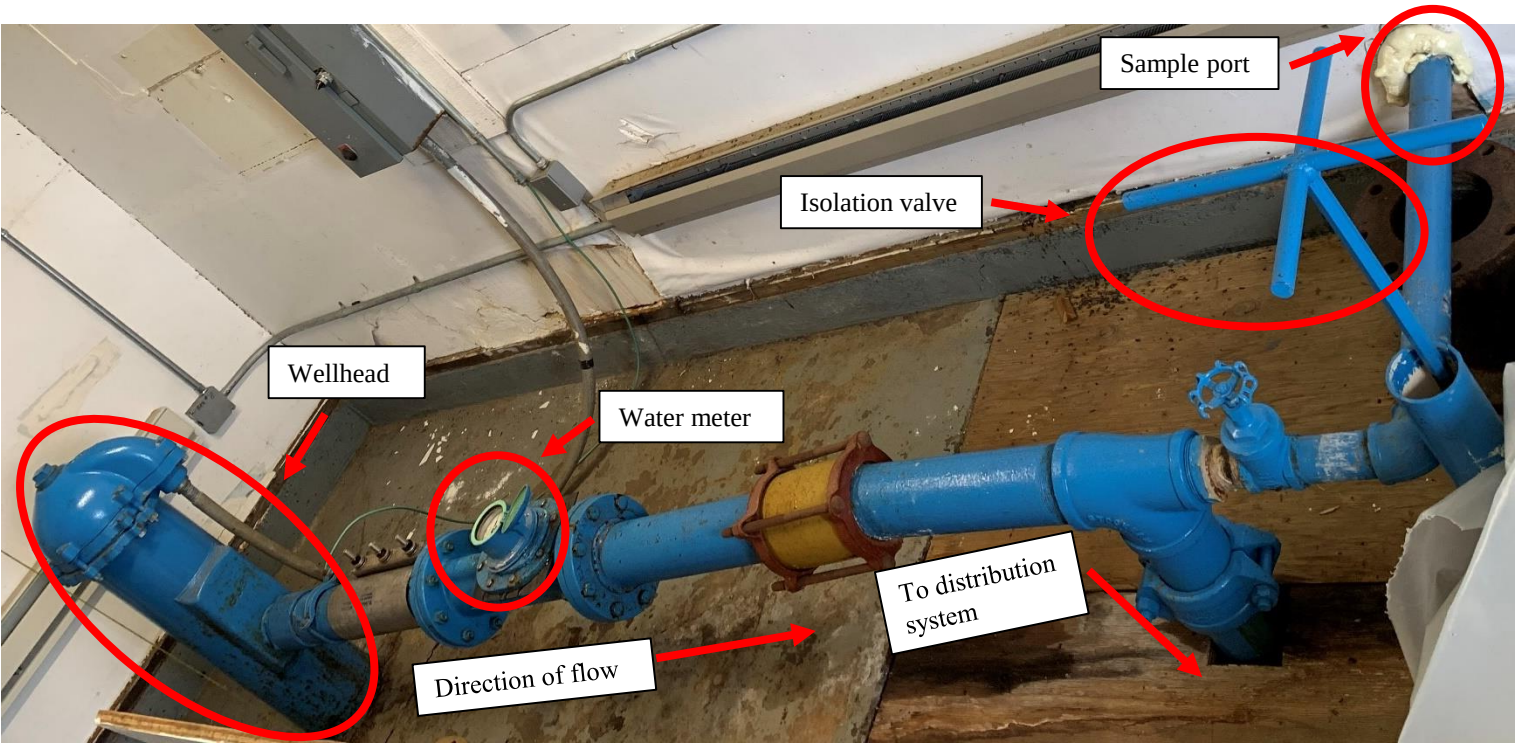
Photo 16: Interior components of north well house.

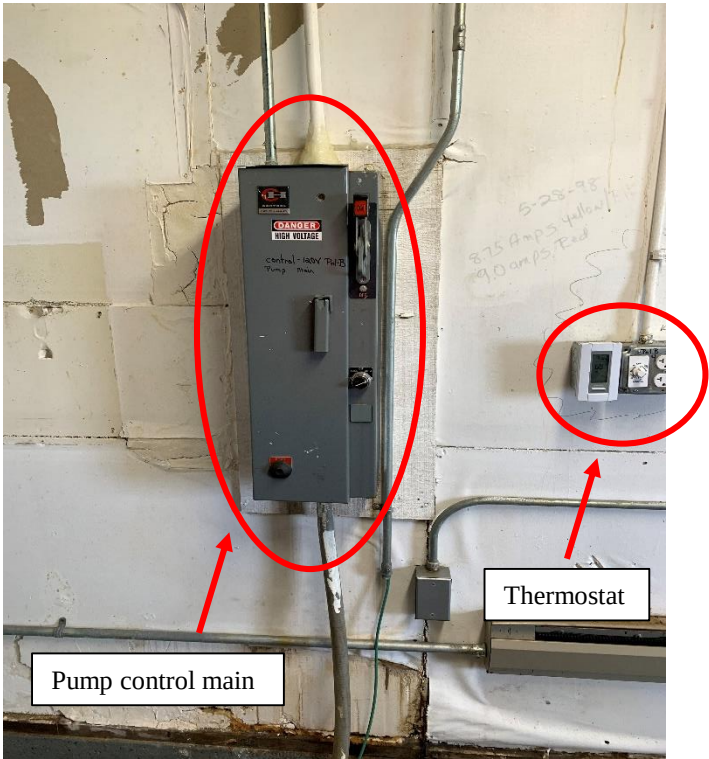
Photo 17: 120V pump control main and thermostat located in north well house.

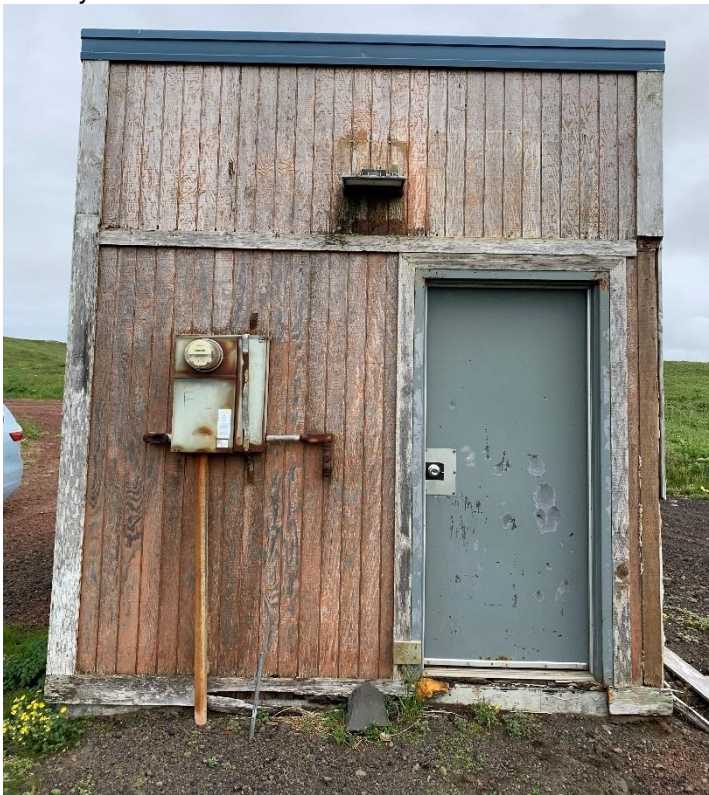
Photo 18: Well house door locked, building in good condition.

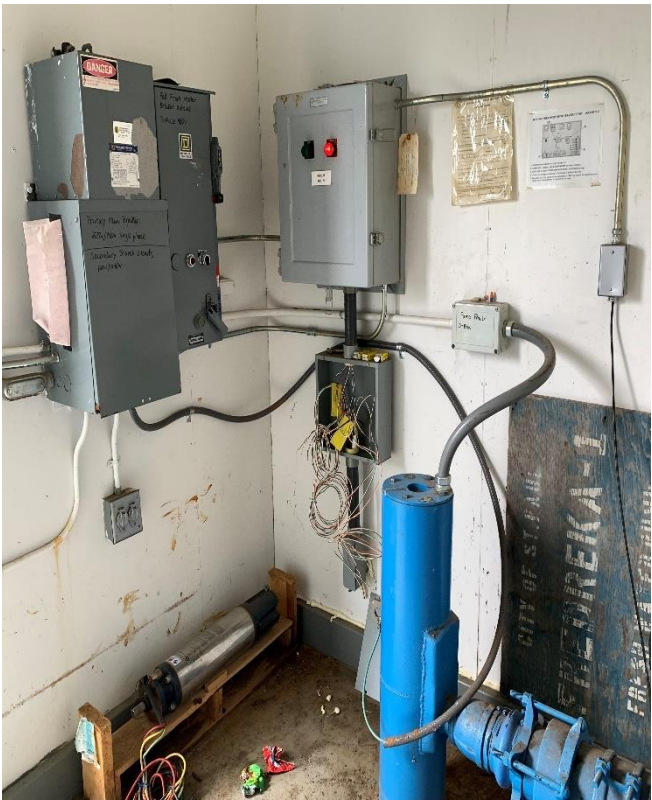
Photo 19: Electrical control boxes.

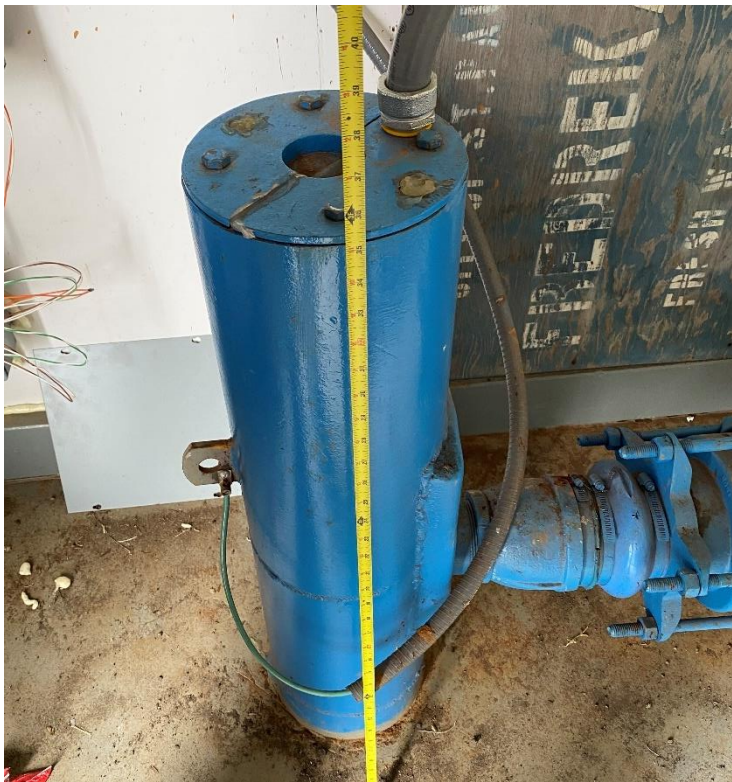
Photo 20: Well casing extending 35 inches above floor.

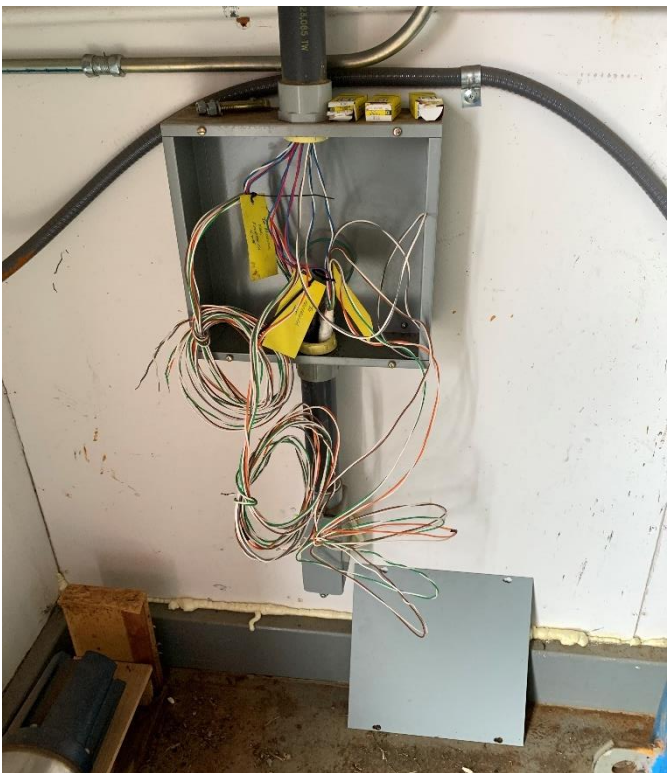
Photo 21: Unsupported electrical for well pump.

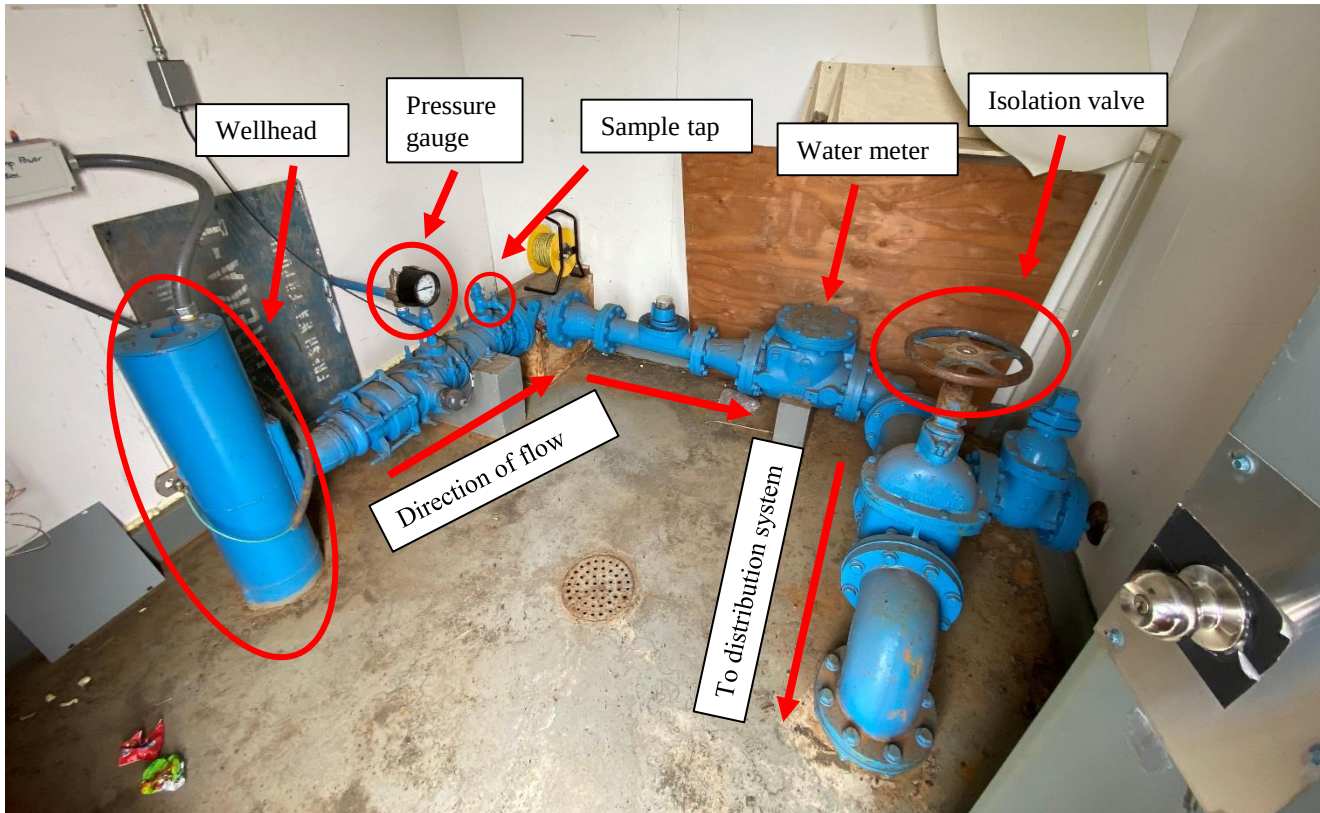
Photo 22: Interior components of well house.

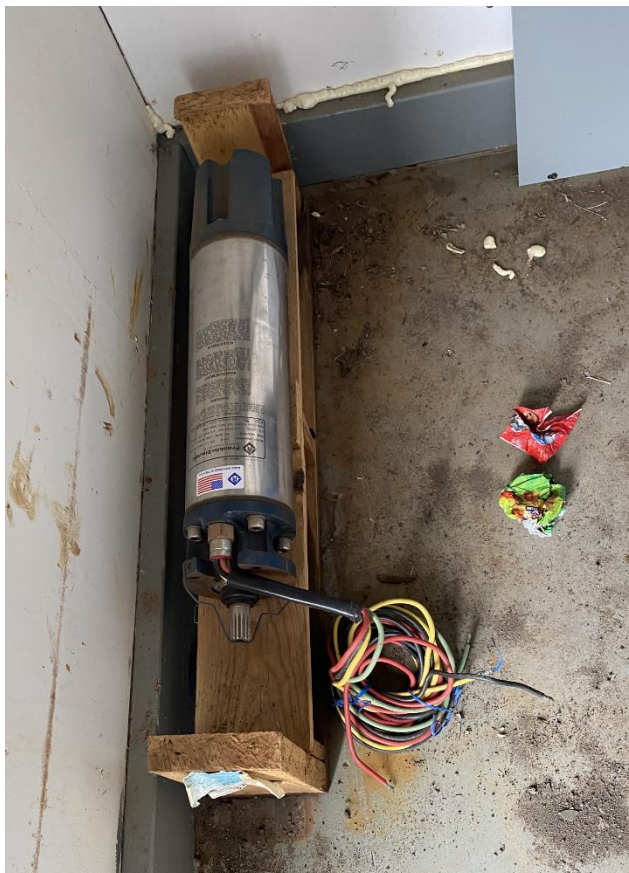
Photo 23: Spare pump.

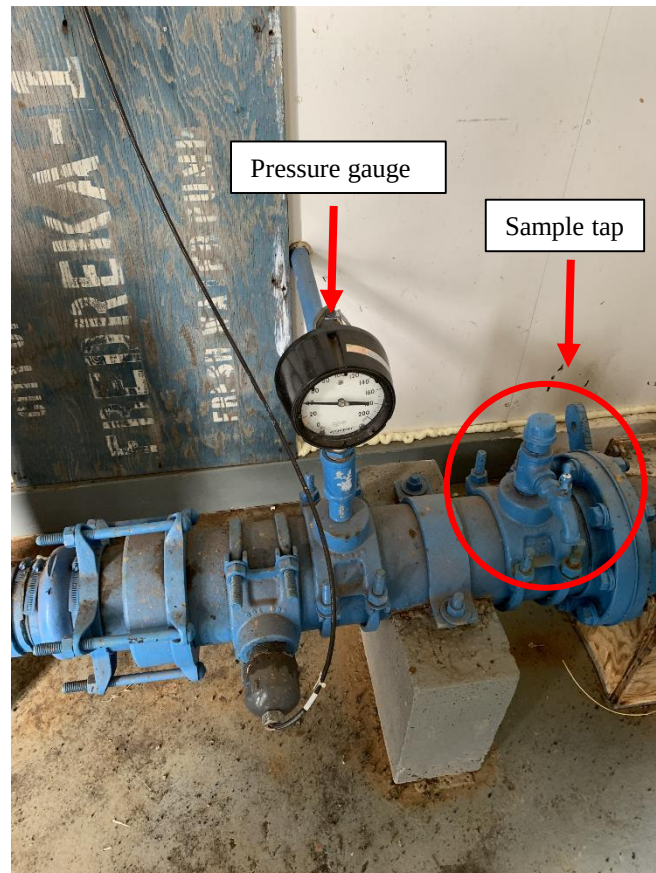
Photo 24: Pressure gauge and sample tap.

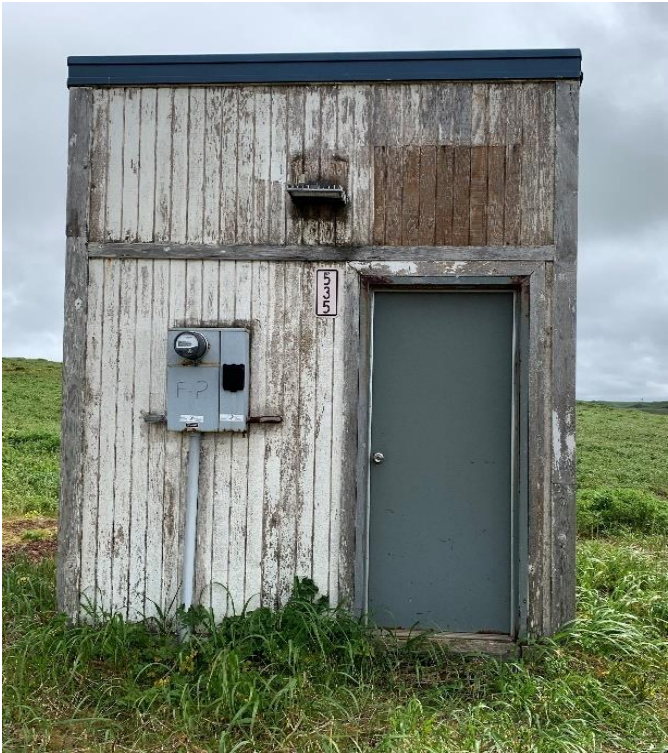
Photo 25: Well house door locked, building in good condition.

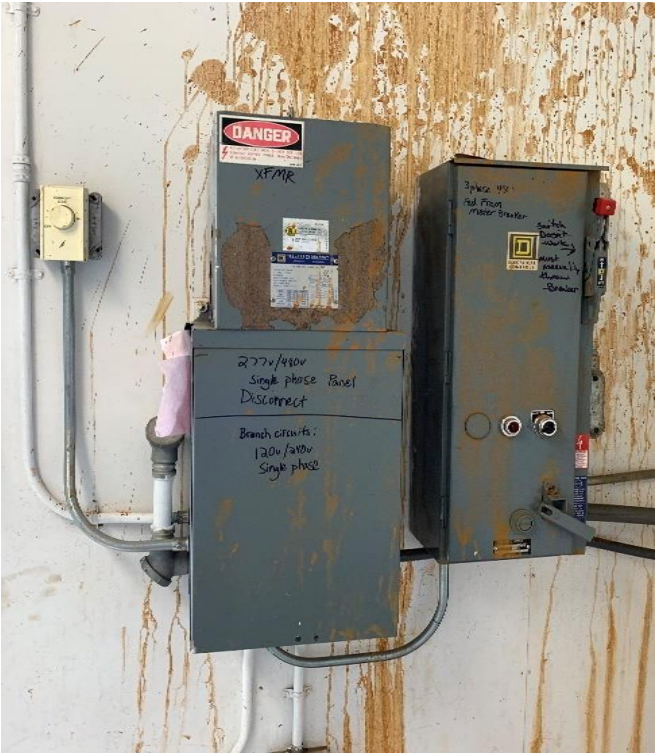
Photo 26: Electrical control boxes.

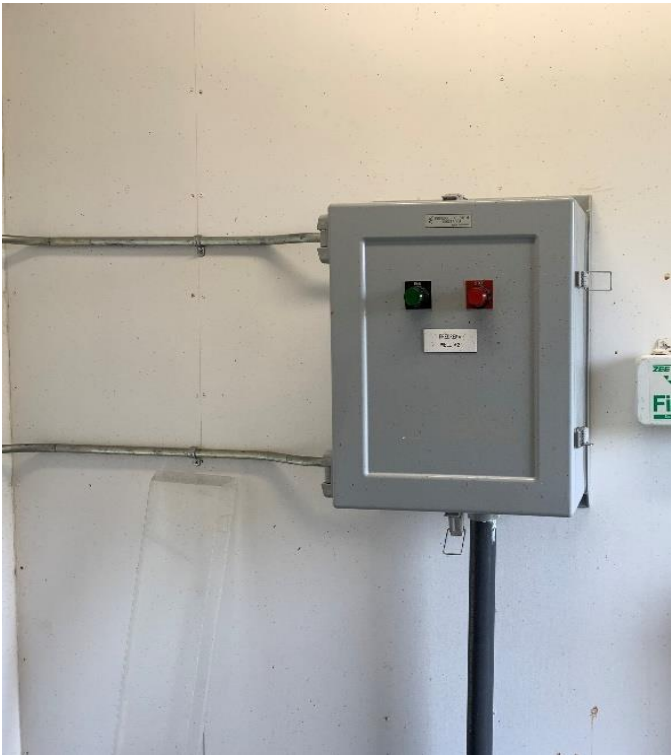
Photo 27: Well pump control.

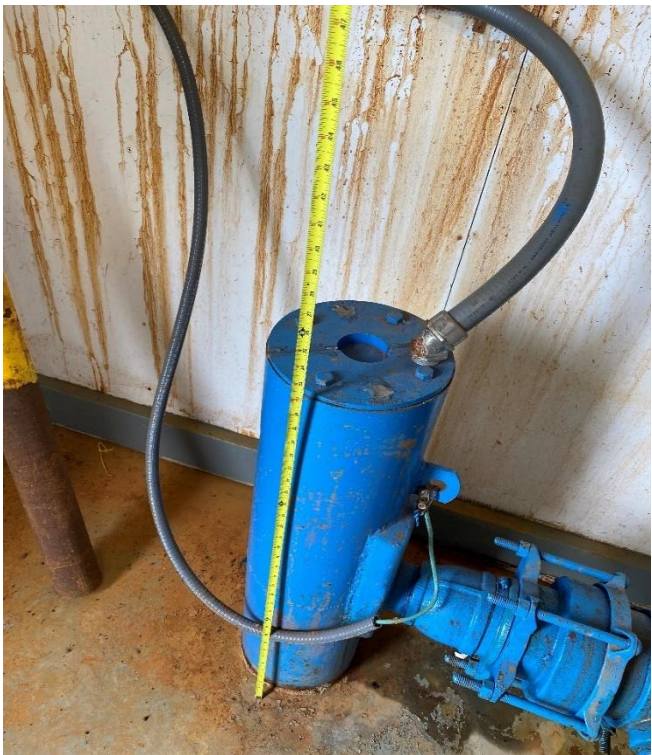
Photo 28: Well casing extending 32.5 inches above floor.

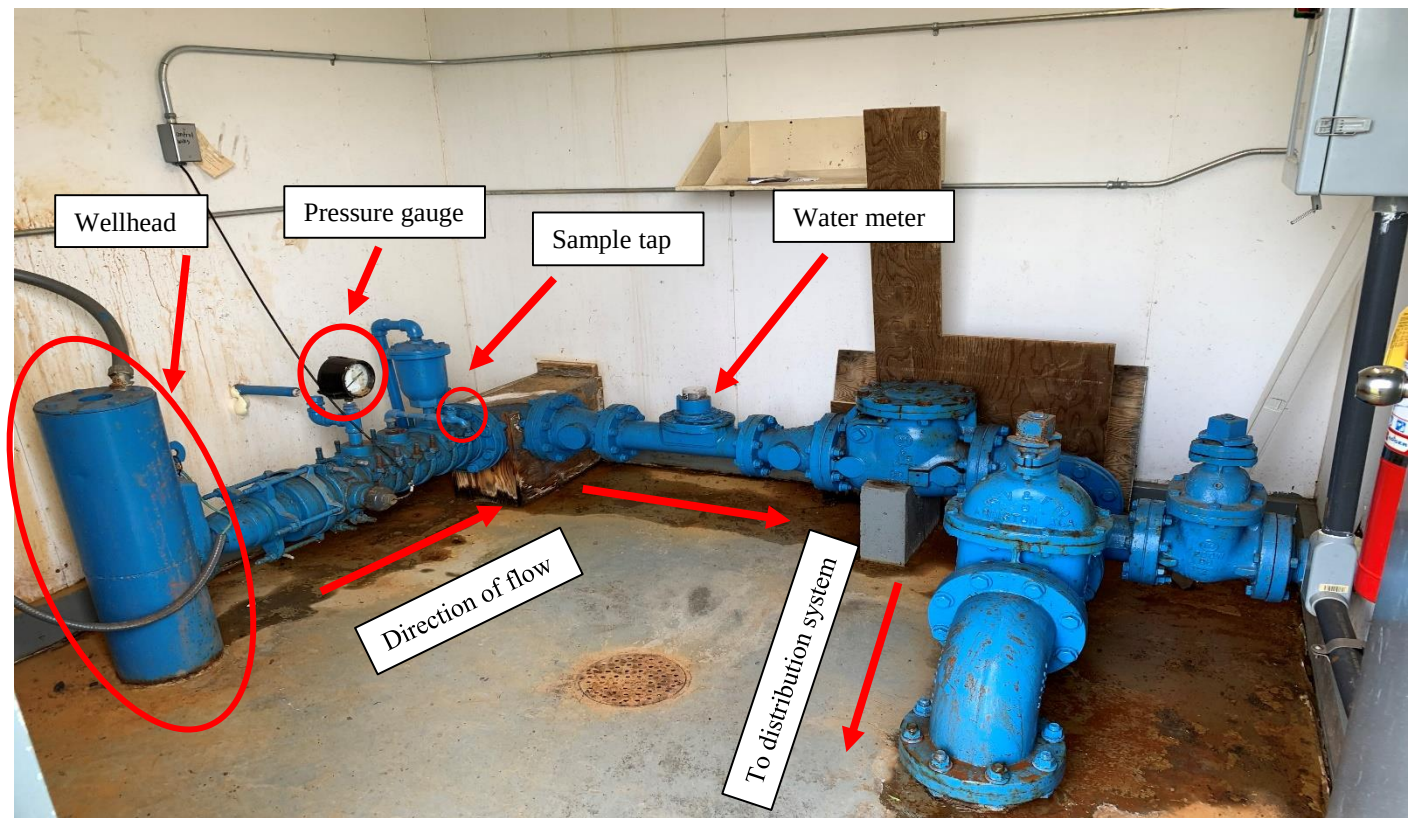
Photo 29: Interior components of wellhouse.

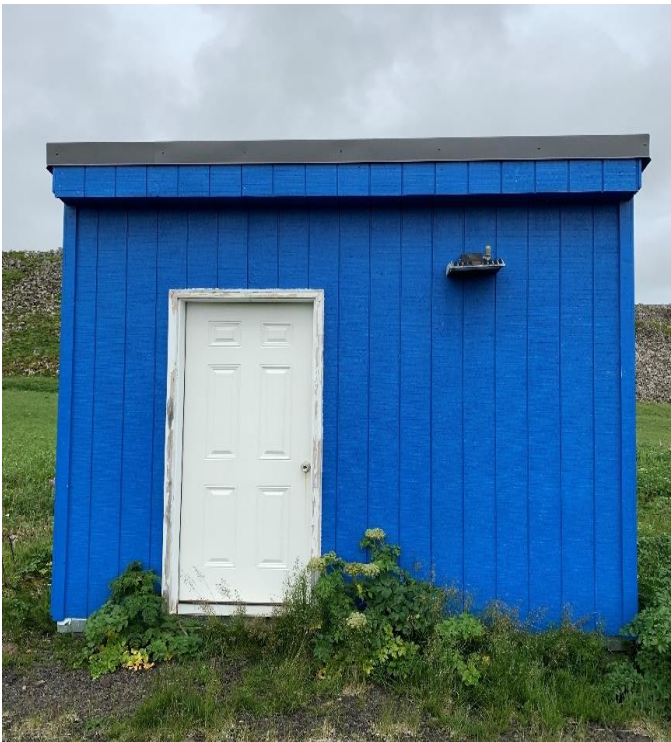
Photo 30: Well house door locked, building in good condition.

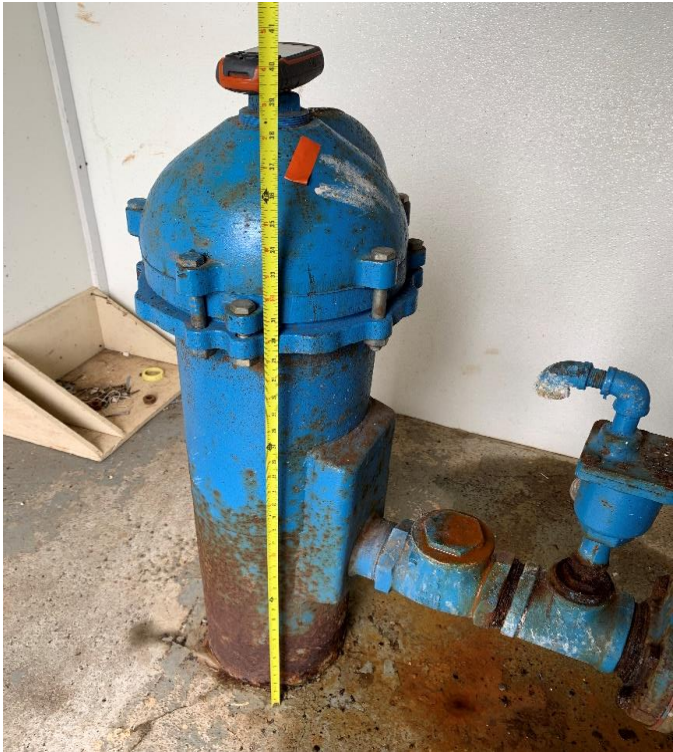
Photo 31: Well casing measured at 30.5 inches above floor.

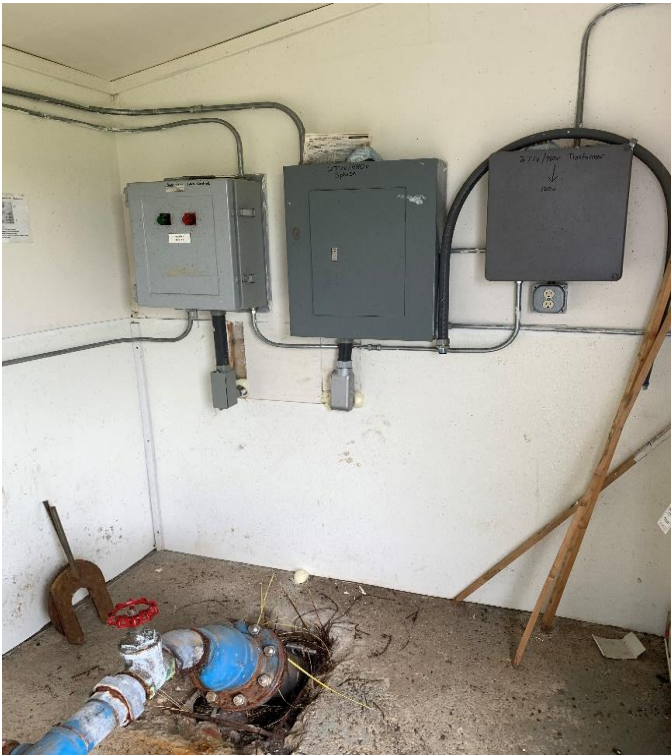
Photo 32: Well house electrical control panels.

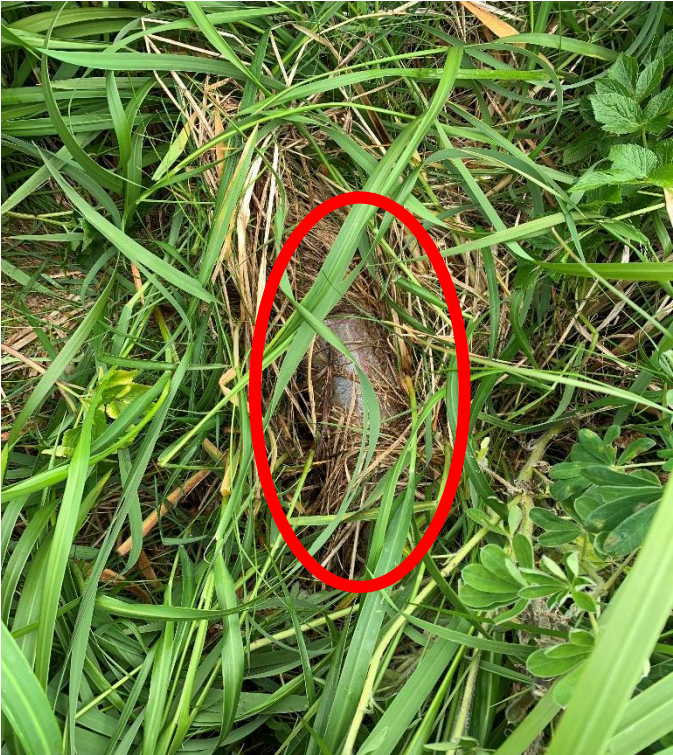
Photo 33: Unburied distribution piping outside of well house.

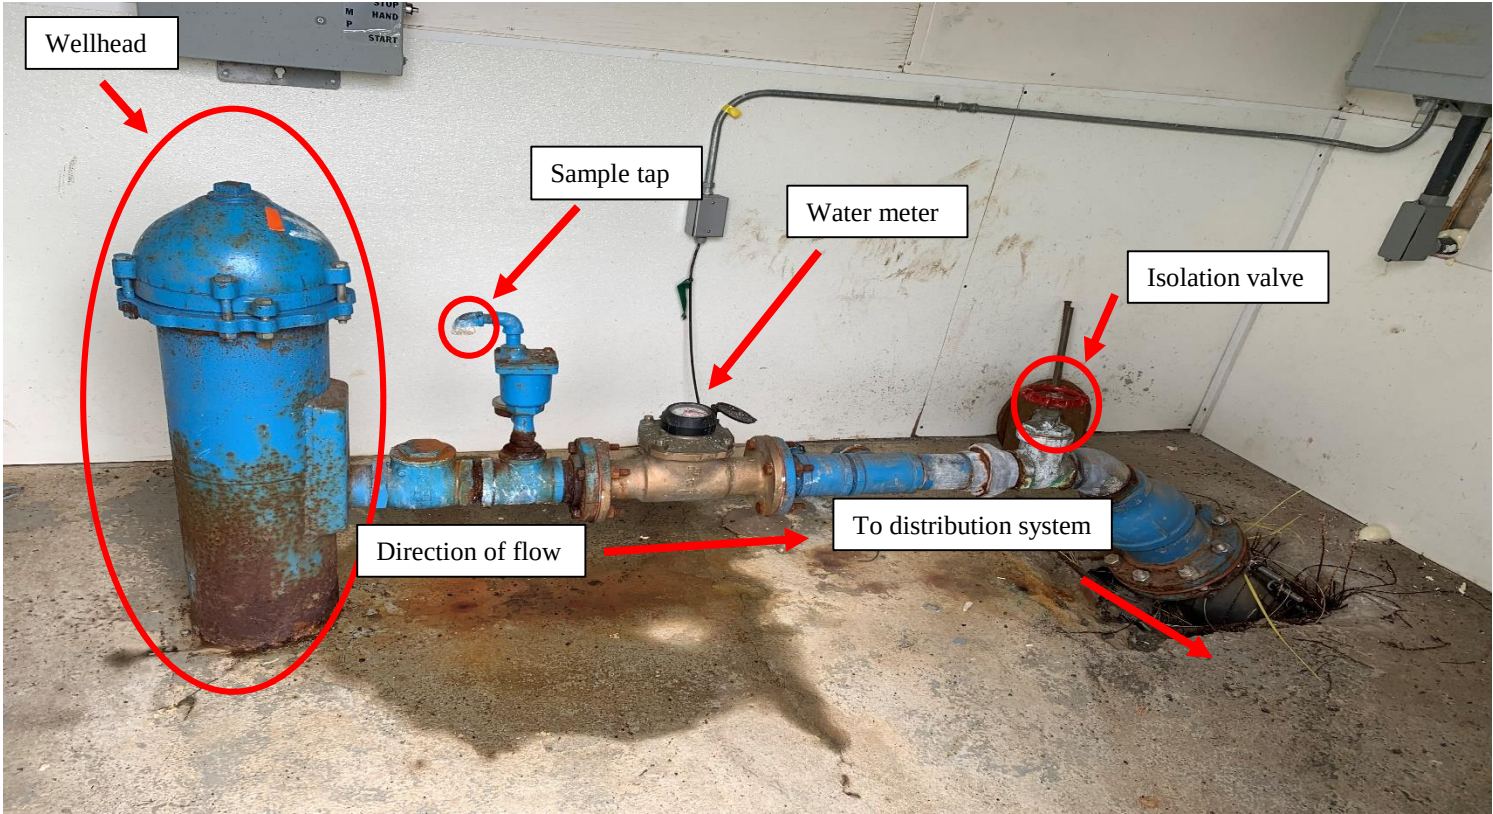
Photo 34: Interior components of well house.

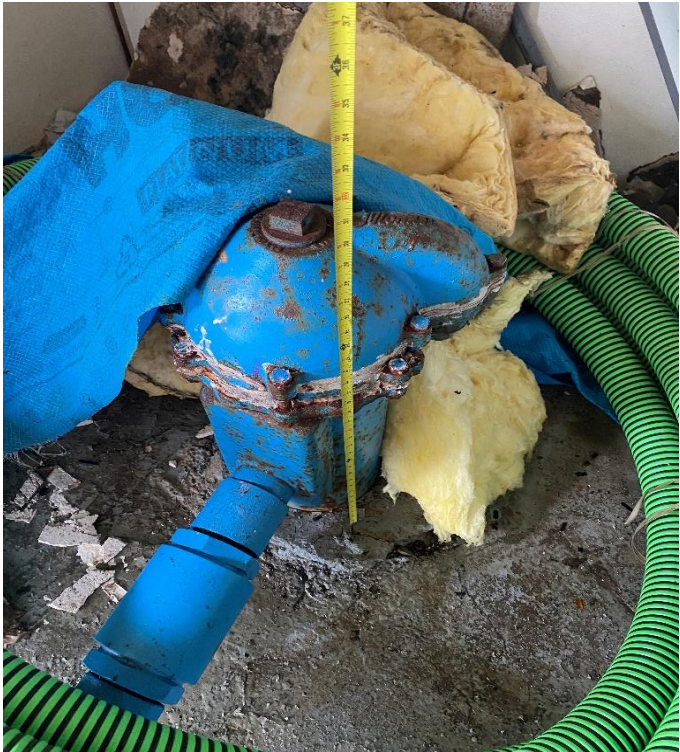
Photo 36: Well casing measured at 20 inches above floor.

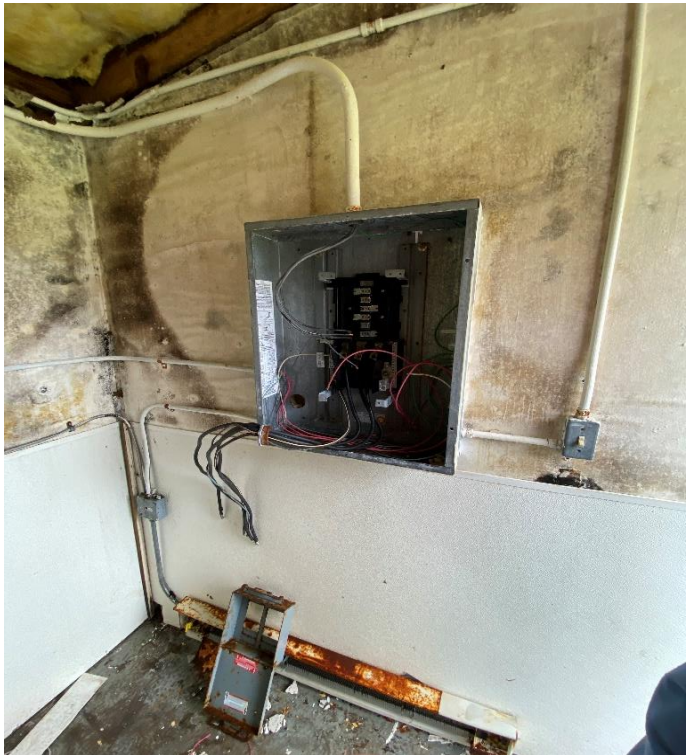
| 2 | If there are any unused wells in the area, are they maintained in a safe and sanitary condition? (If no, describe and note the location(s) on the system site plan map.)<br>Notes: WL006/Fredrika 4 has an open electrical port on the well cap and is unused. | <input type="checkbox"/> Yes<br><input checked="" type="checkbox"/> No<br><input type="checkbox"/> Unknown |

Photo 37: Well house electrical control panels disabled.

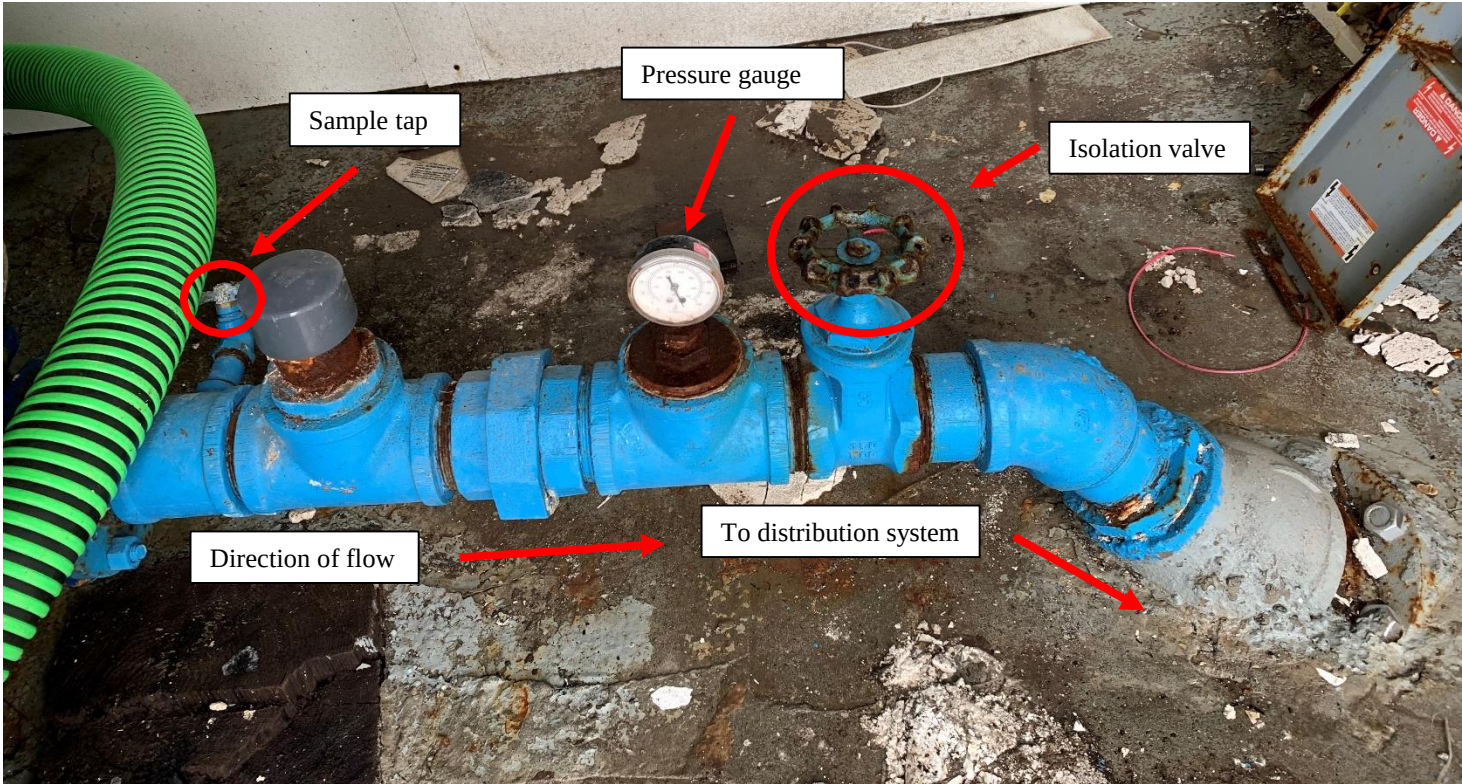
Photo 38: Interior components of well house.

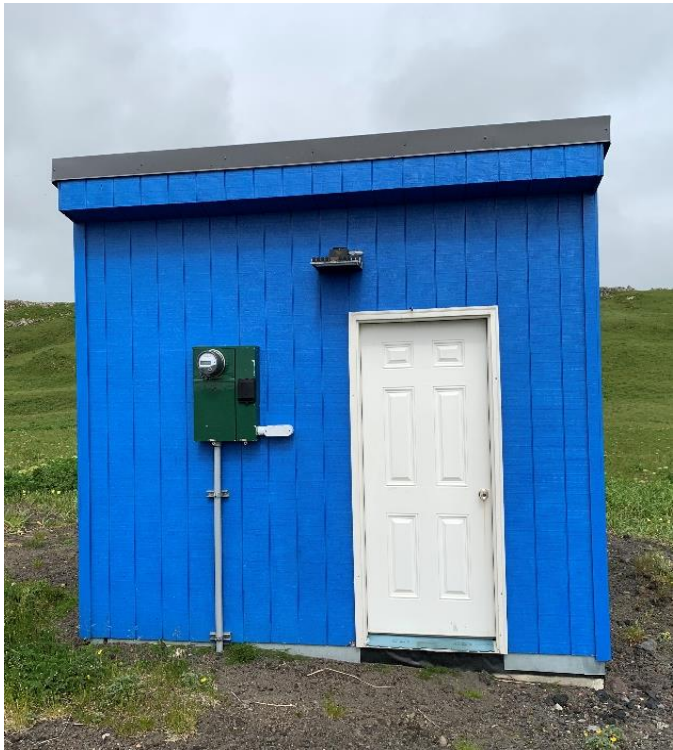
Photo 39: Well house door locked, building in good condition.
