ALASKA NATIVE  
TRIBAL HEALTH  
CONSORTIUM

RE: Sanitary Survey of the Saint Paul Island Community Water System

## Sanitary Survey Photo Log

August 7th, 2024

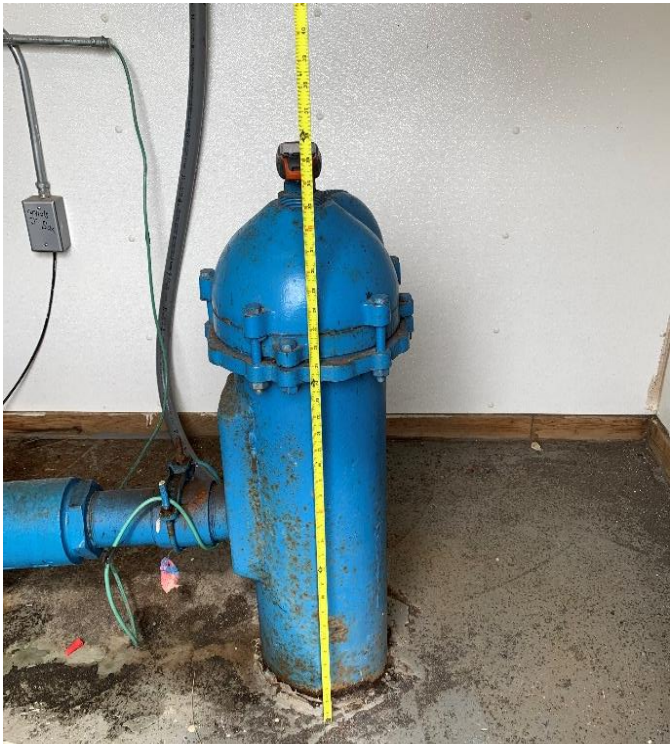
Photo 40: Well casing measured at 25 inches above floor.

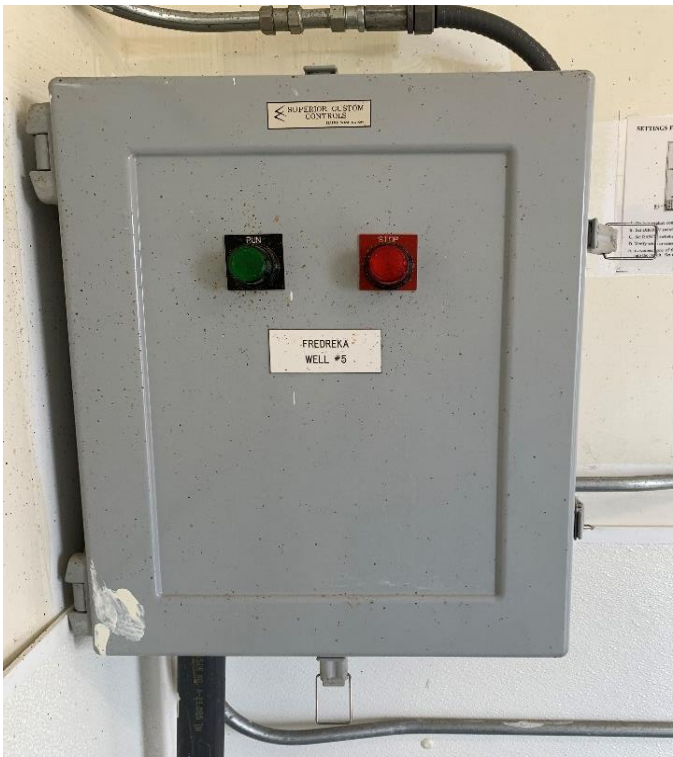
Photo 41: Fredrika well #5 electrical box.

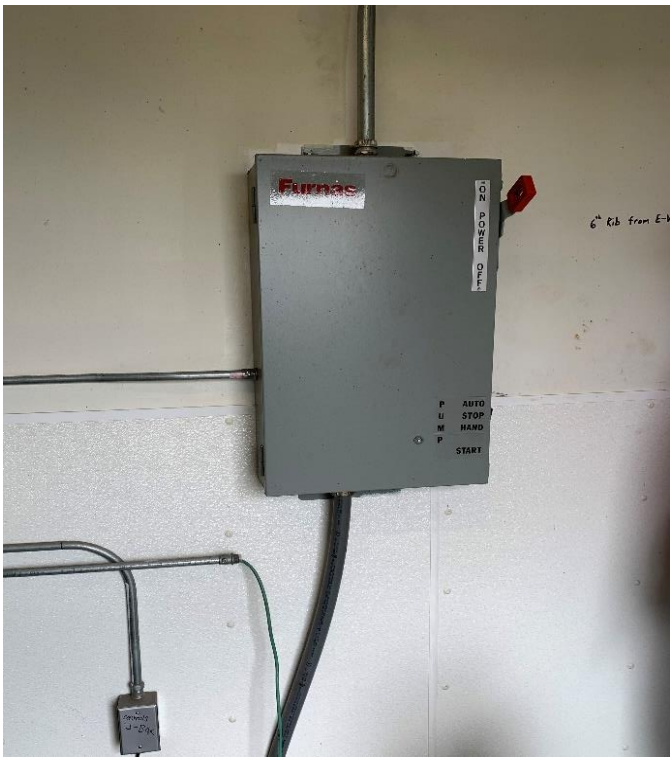
Photo 42: Fredrika well #5 pump control electrical box.

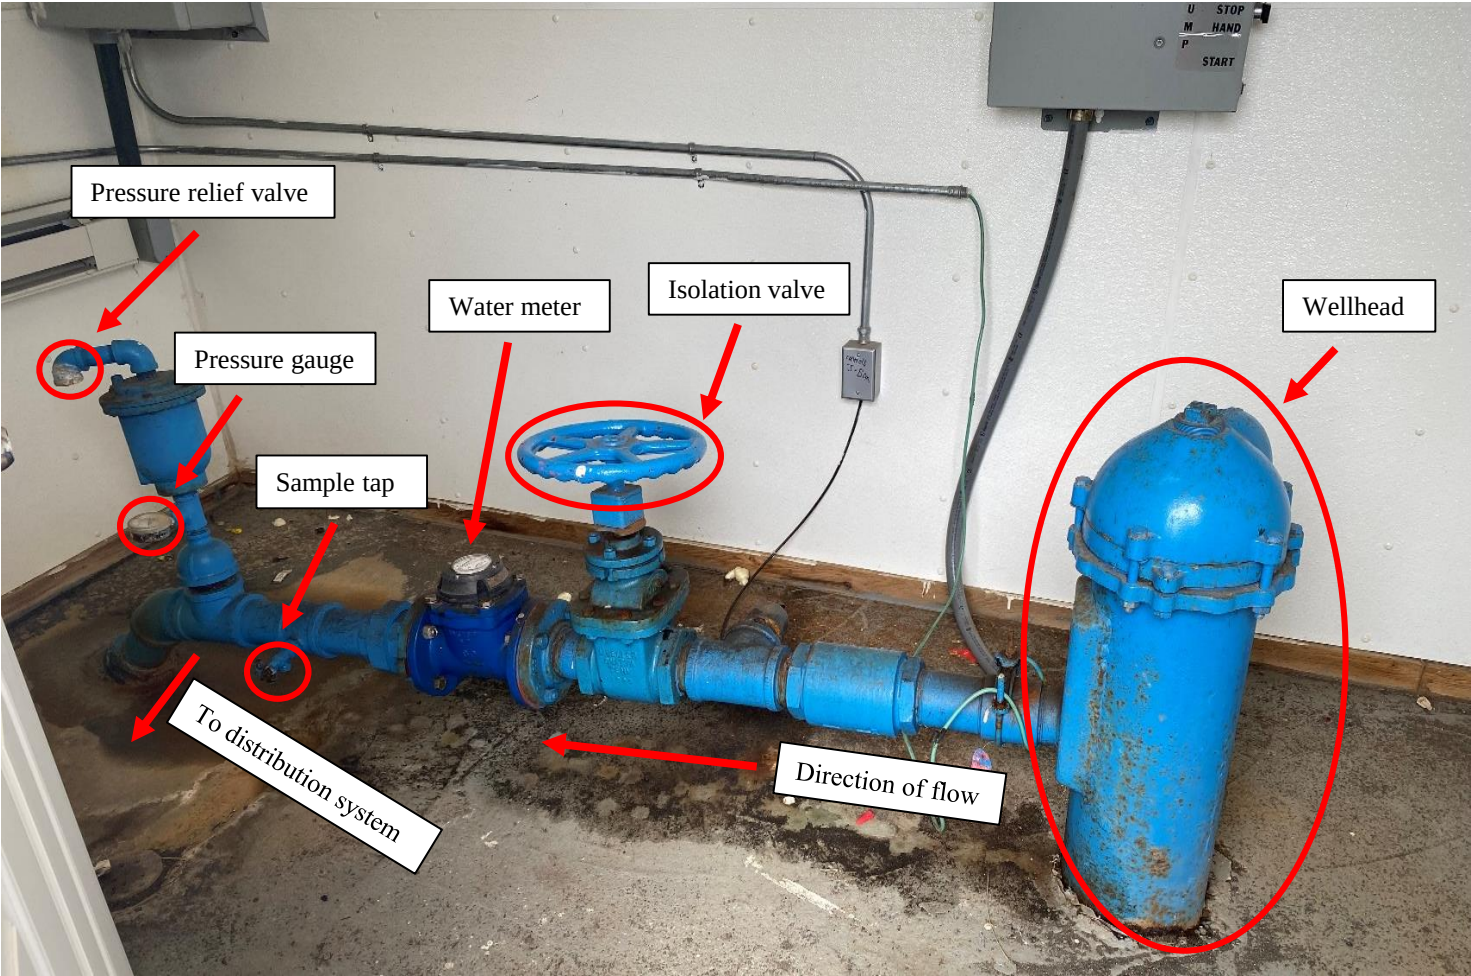
Photo 43: Interior components of well house.

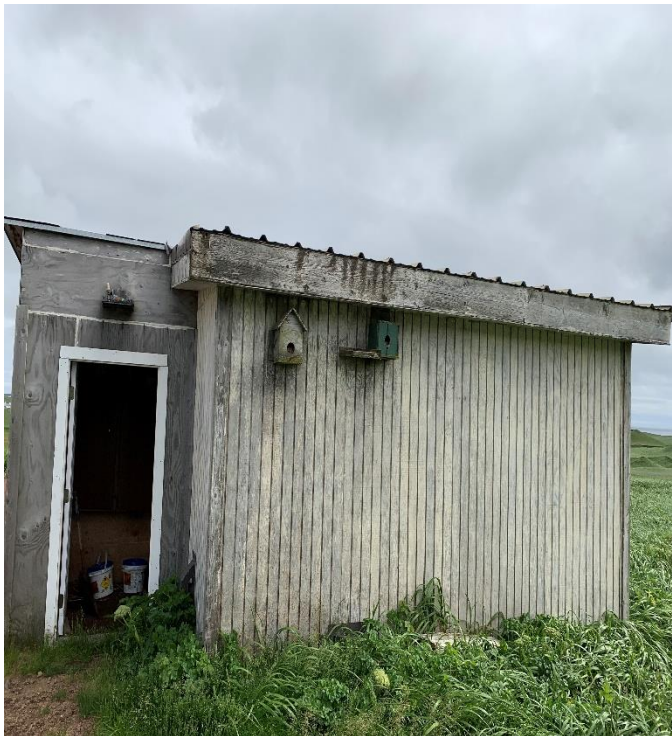
Photo 44: Exterior of WTP in good condition.

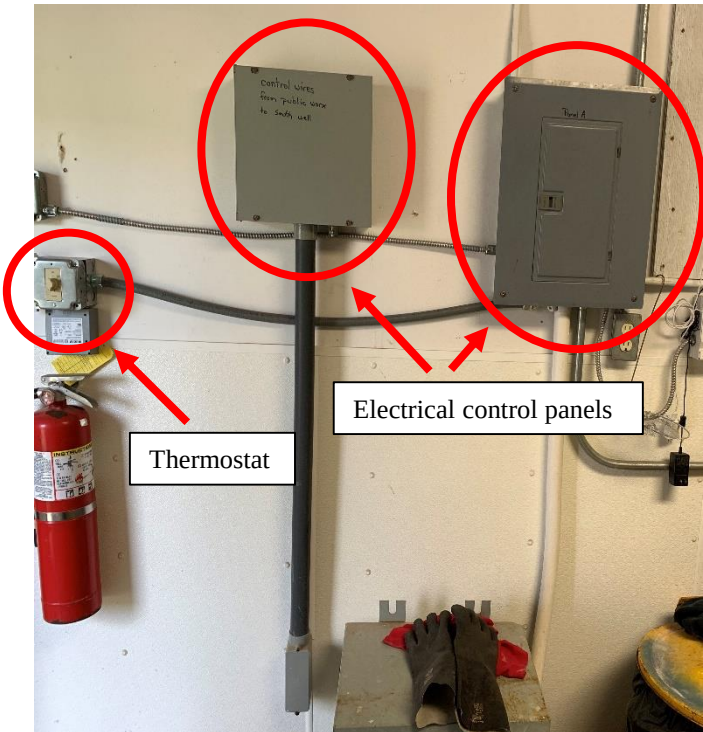
Photo 45: Electrical control panels, thermostat, fire extinguisher.

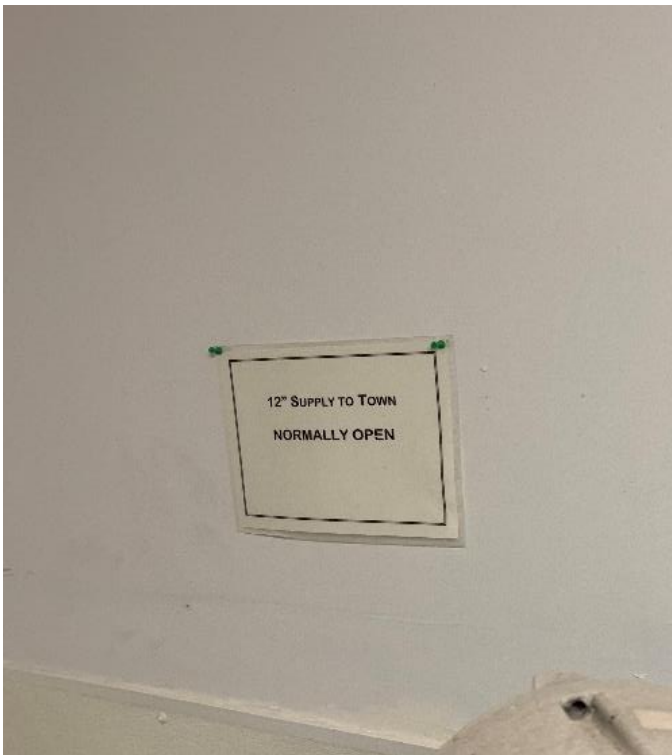
Photo 46: Clear signage throughout WTP.

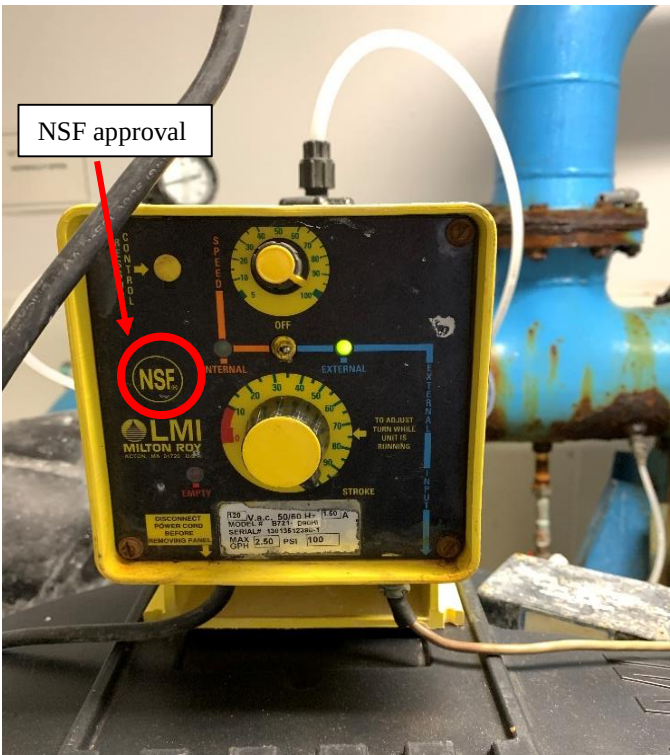
Photo 47: LMI, Model B721, Chlorine injection pump, NSF approved.

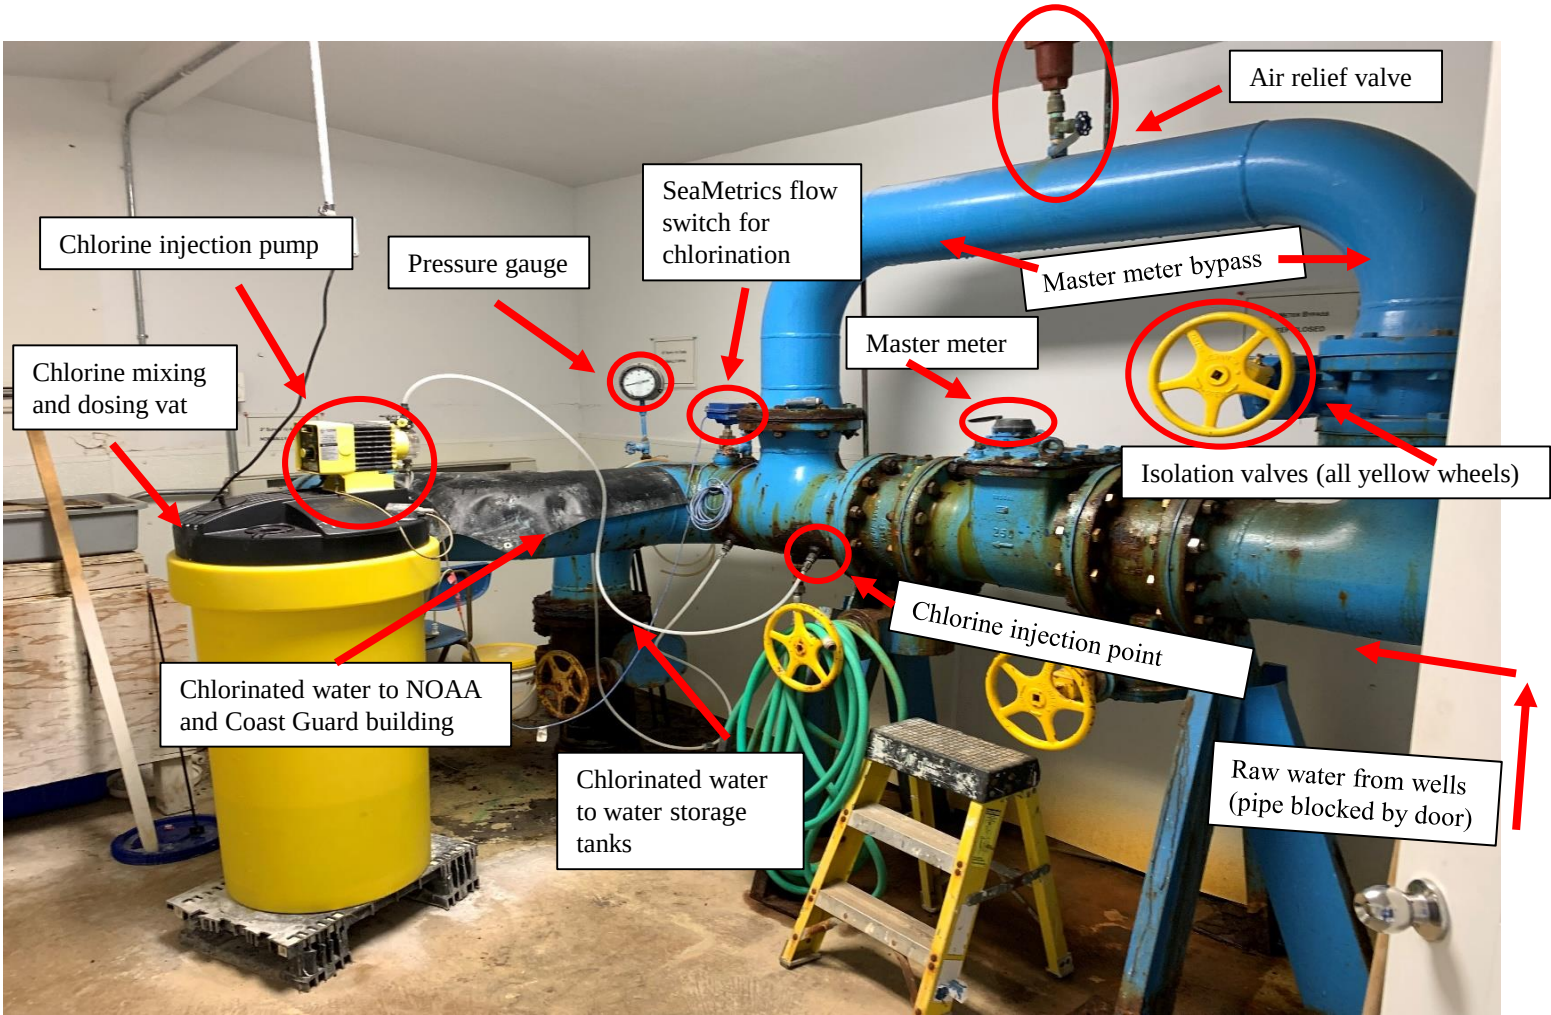
Photo 48: Interior components of WTP.

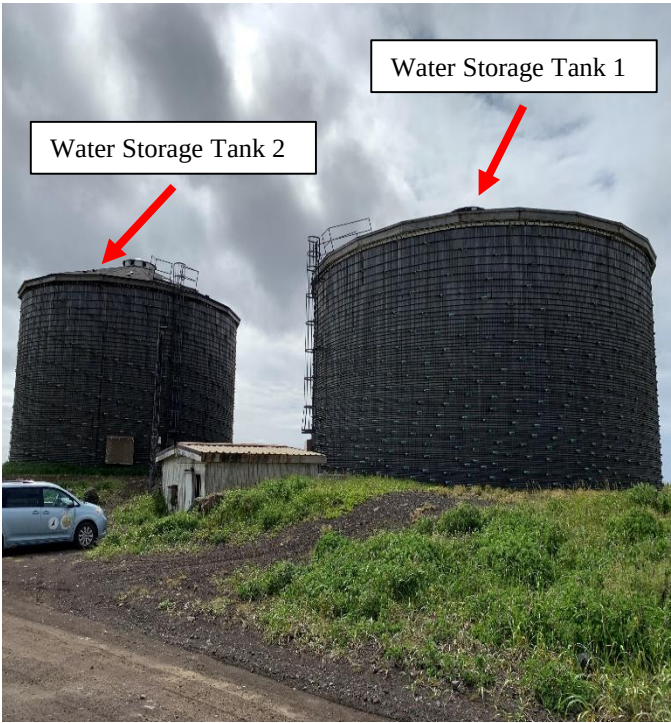
Photo 49: Exterior of water storage tanks in good condition.

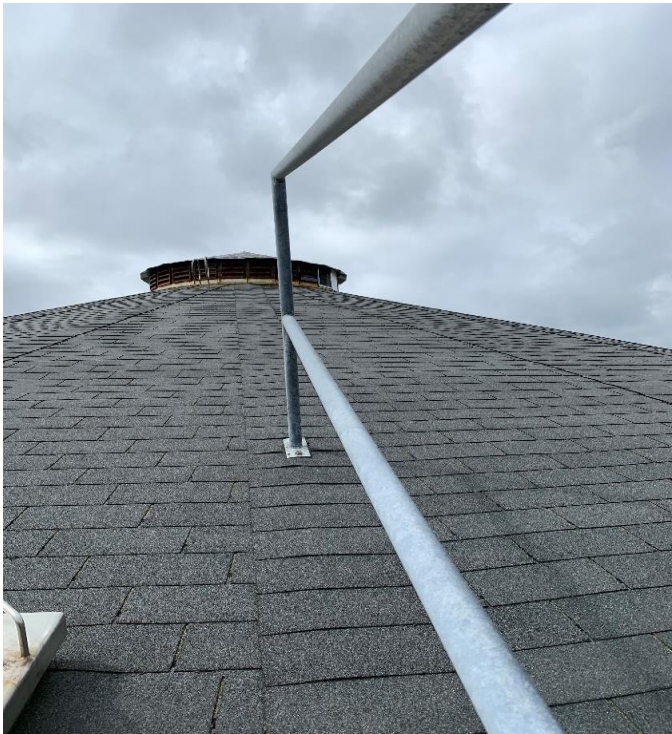
Photo 50: Top of WST 1 in good condition.

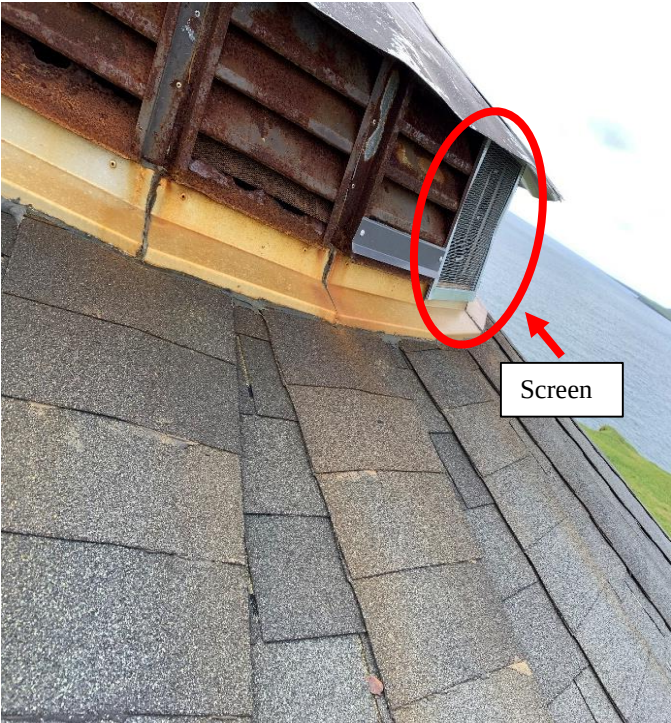
Photo 51: Screen on WST 1.

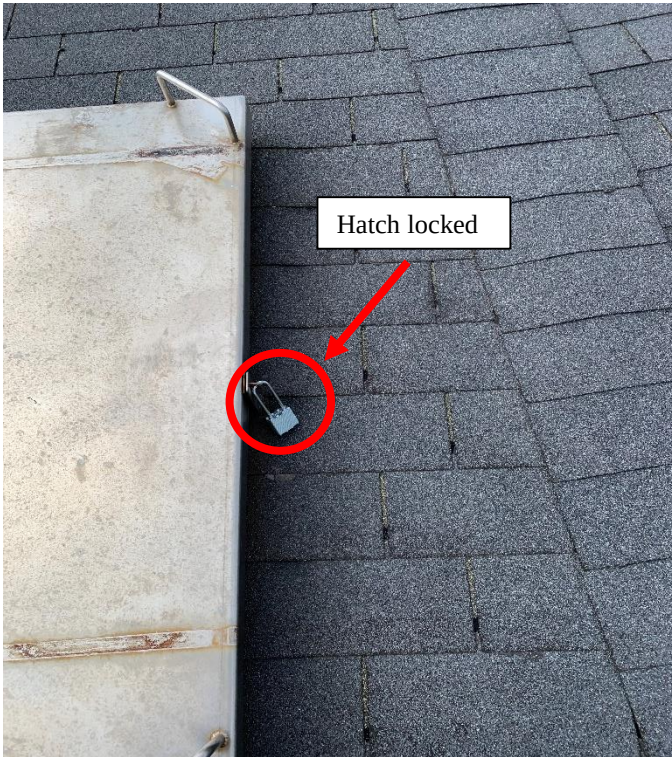
Photo 52: Hatch locked on WST 1.

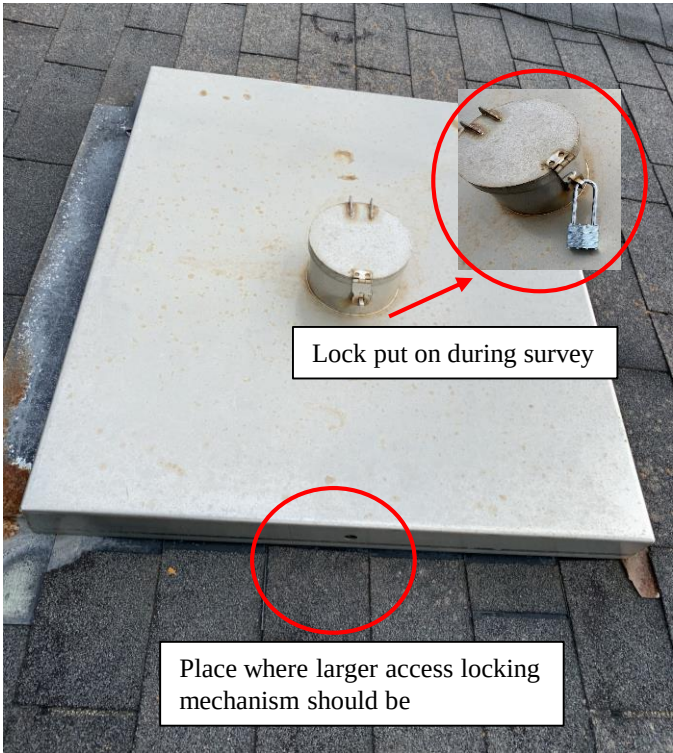
Photo 55: Smaller access hatch on WST 2 locked.

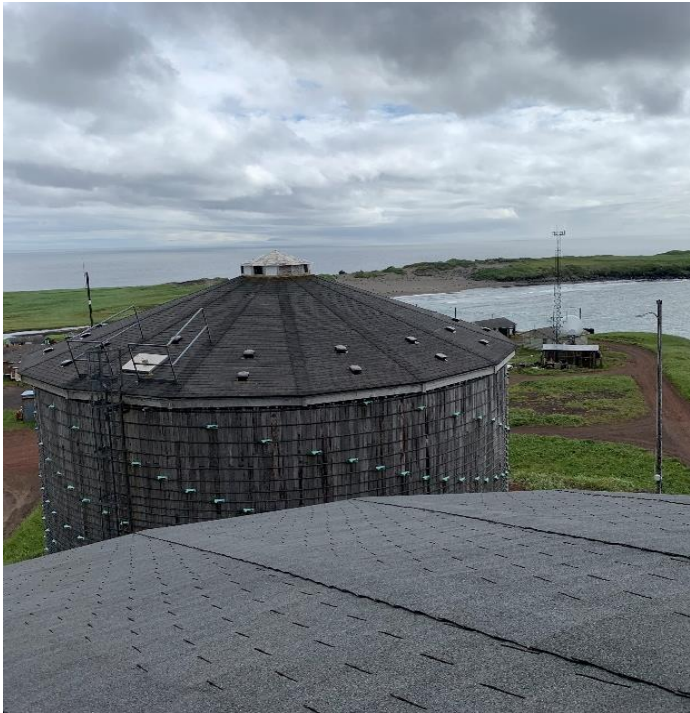
Photo 57: Top of WST 2 in good condition.

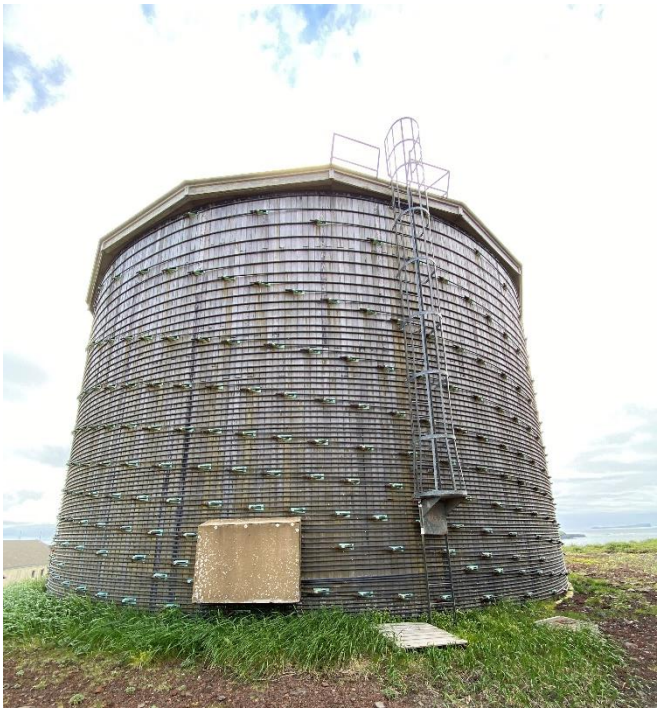
Photo 58: Exterior of WST 2 in good condition.

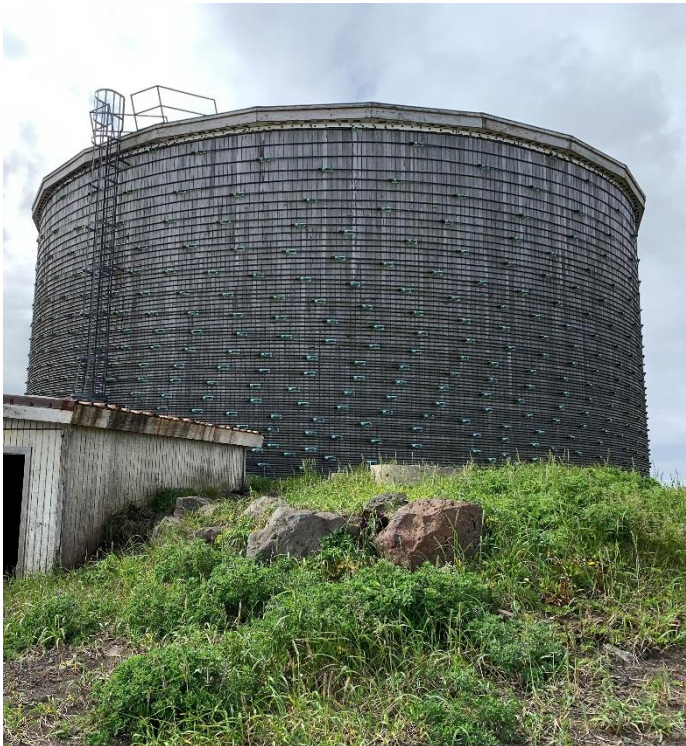
Photo 59: Exterior of WST 1 in good condition.

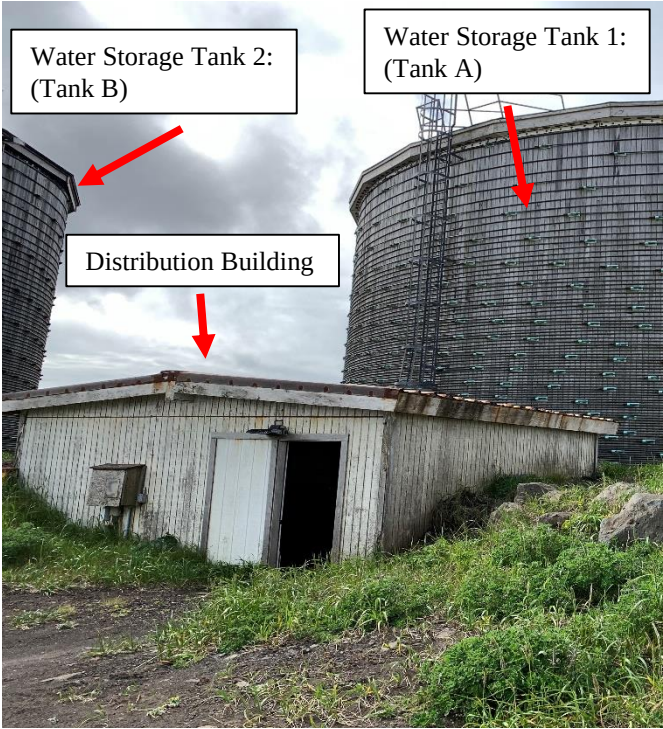
Photo 60: Exterior of distribution building in good condition.

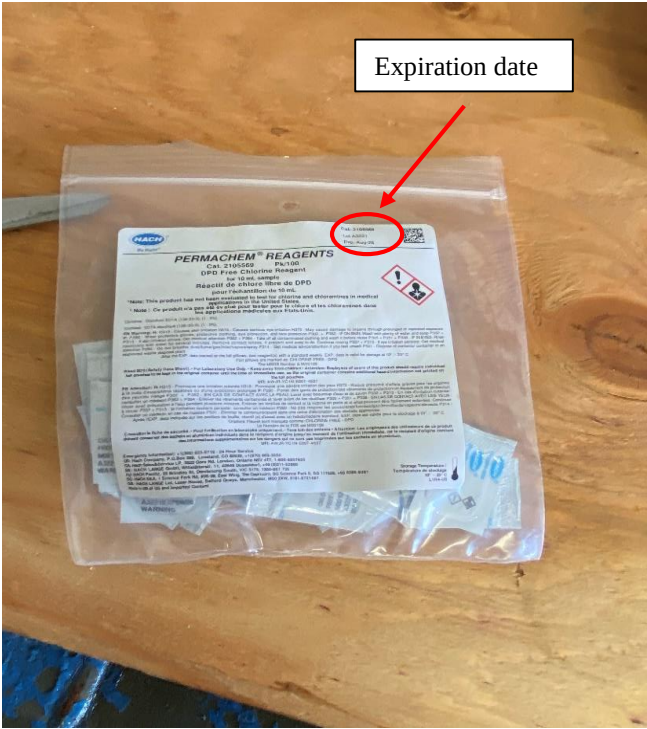
Photo 61: Chlorine testing reagents in date (expire August 2026).

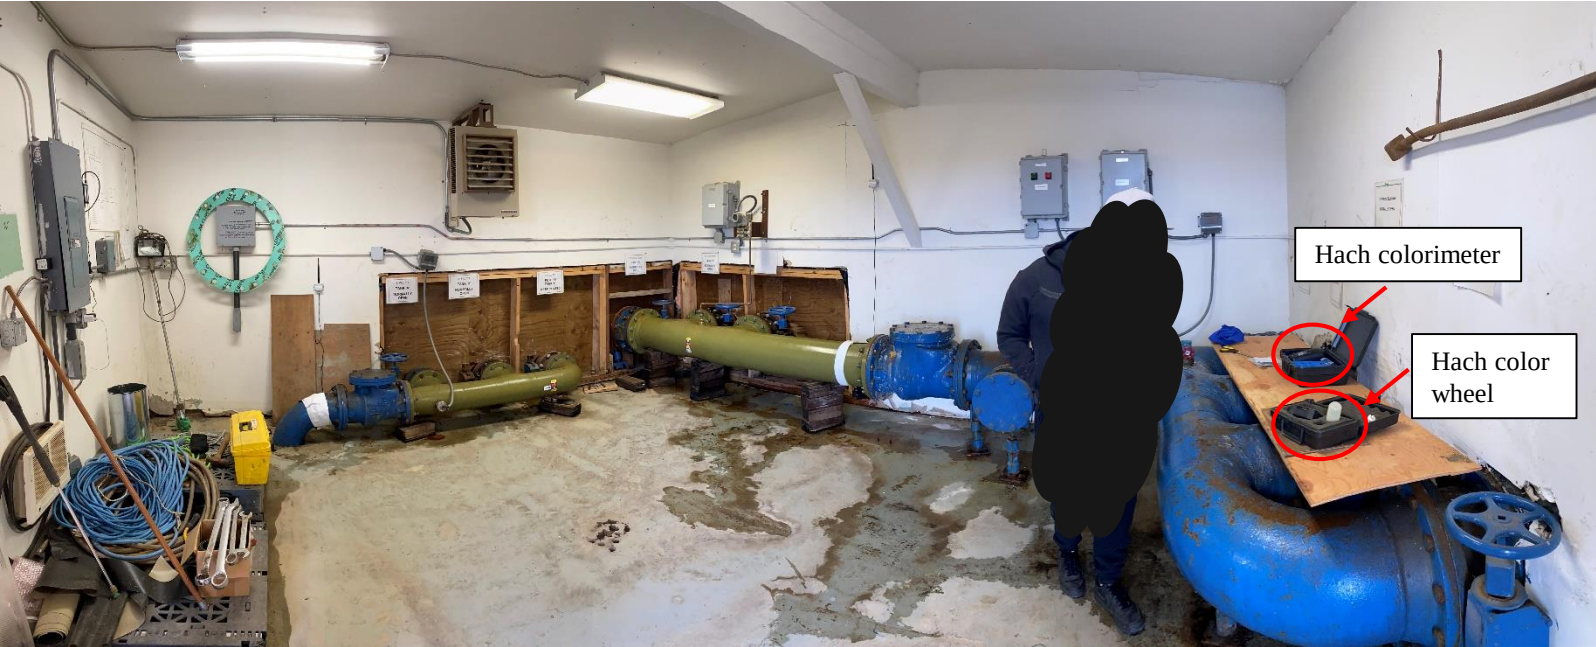
Photo 62: Full image of distribution building for reference.

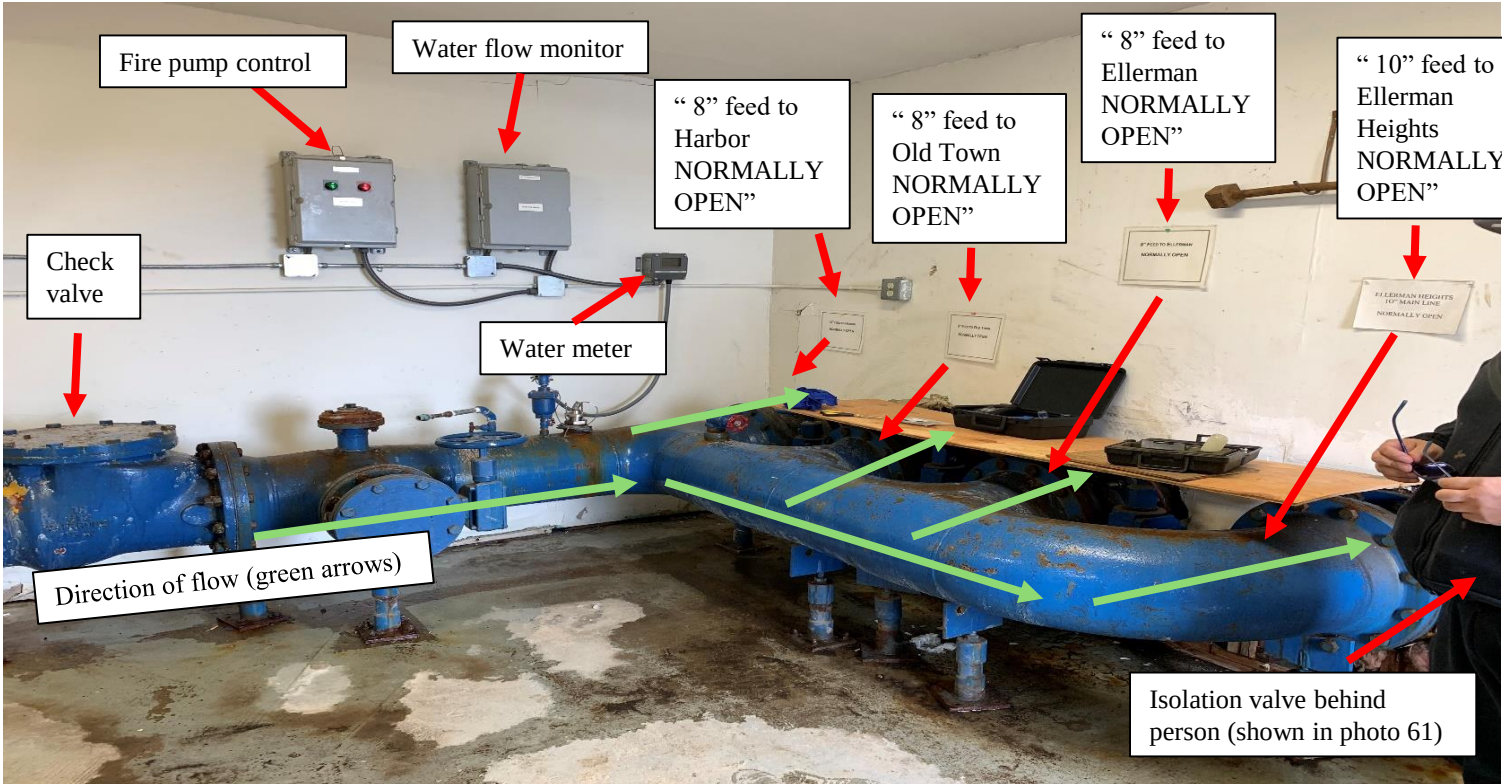
Photo 63: Interior components of right side of distribution building.

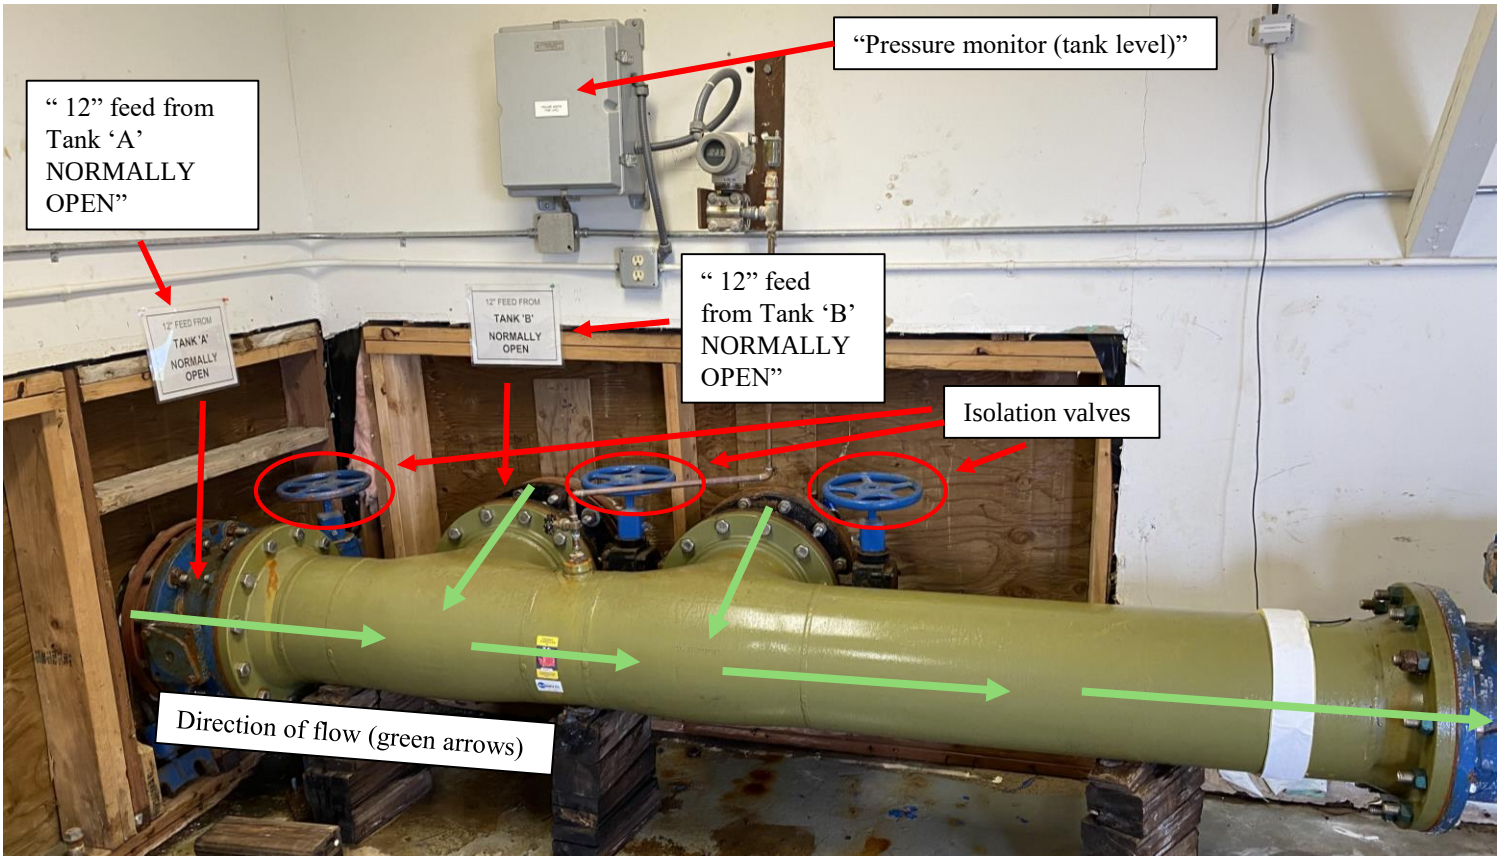
Photo 64: Interior components of middle of distribution building.

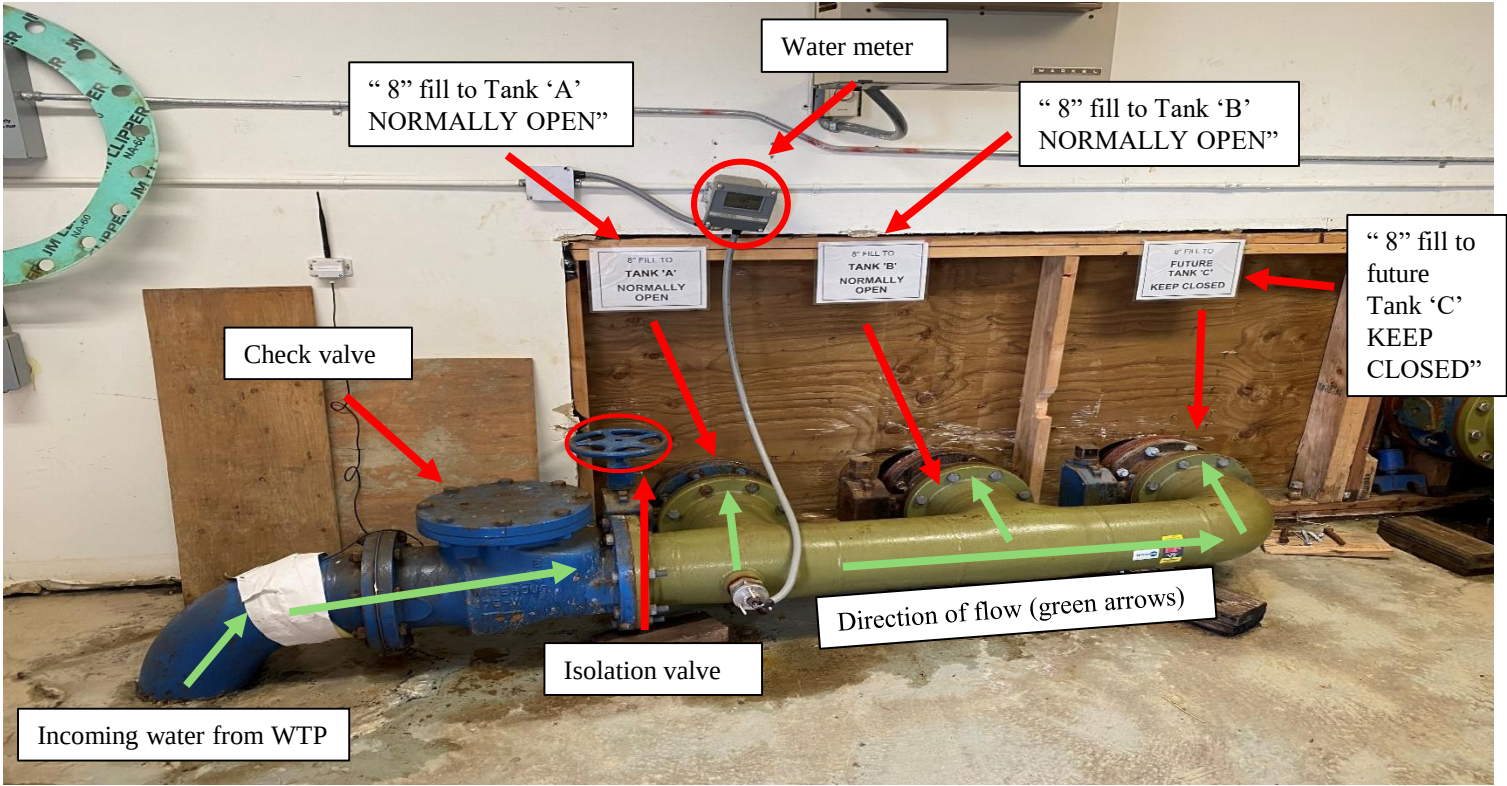
Photo 65: Interior components of left side of distribution building.
