ALASKA NATIVE  
TRIBAL HEALTH  
CONSORTIUM

RE: Sanitary Survey of the Saint Paul Island Community Water System

## Sanitary Survey Photo Log

August 7th, 2024

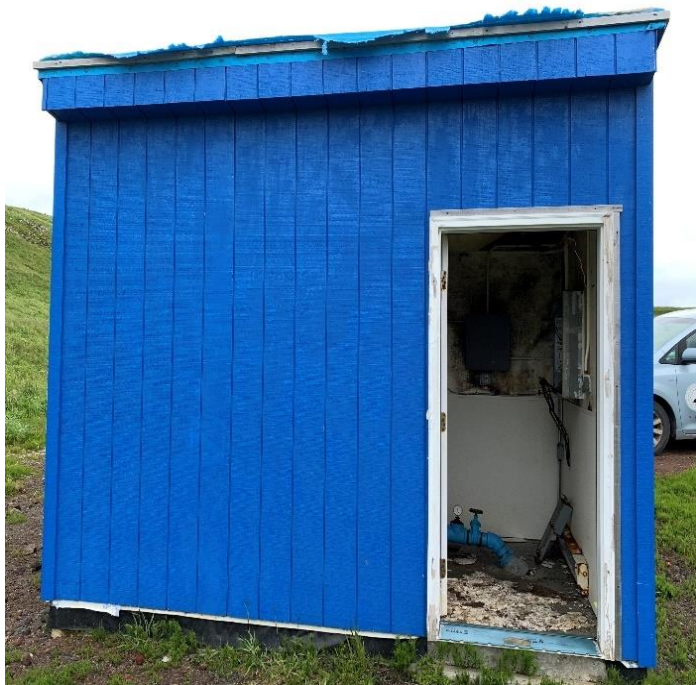
Photo 35: Well house exterior, roof in disrepair.

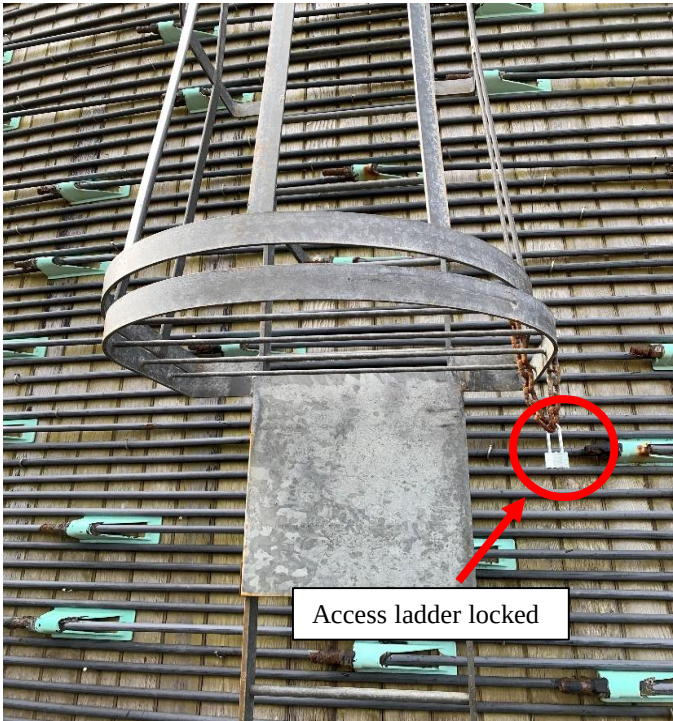
Photo 53: Access ladder locked on WST 1.

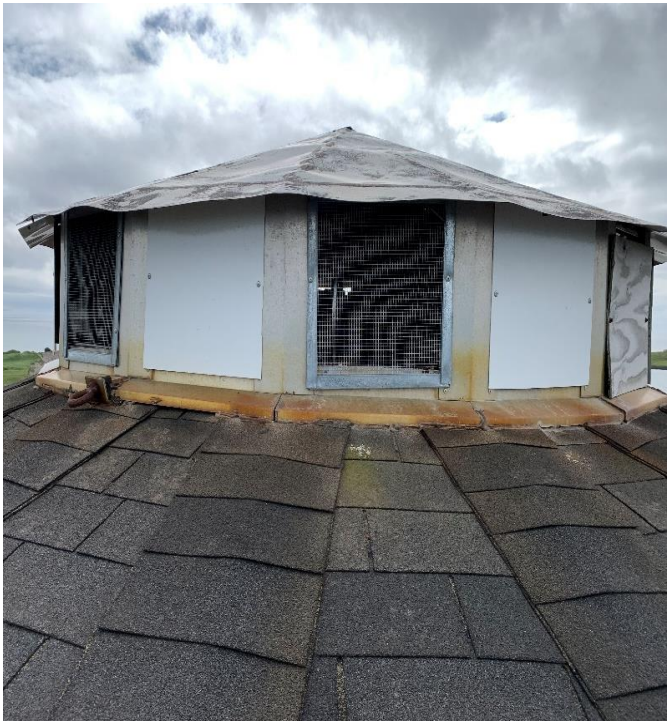
Photo 54: Top of WST 2 screened.
