ALASKA NATIVE  
TRIBAL HEALTH  
CONSORTIUM

RE: Sanitary Survey of the Saint Paul Island Community Water System

## Sanitary Survey Photo Log

August 7th, 2024

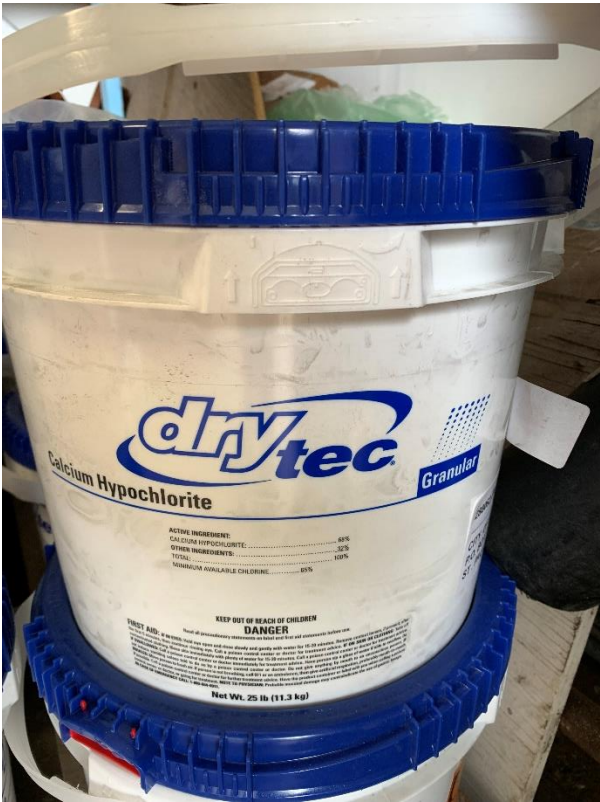
Photo 6: Chemical disinfectant used in system is calcium hypochlorite.

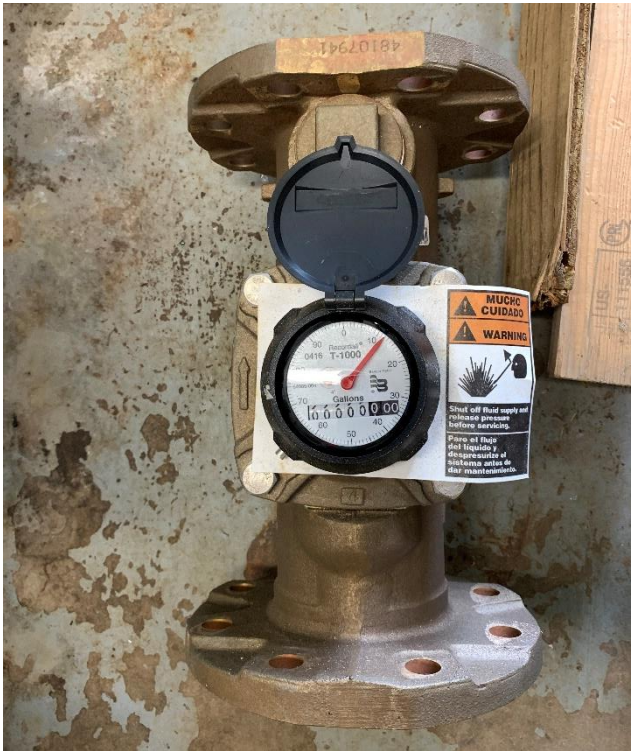
Photo 11: Spare water meter located in north well house.
